Aging of Composite Aircraft Structures

John Tomblin, PhD
Executive Director, NIAR

B737-Stabilizer FAA Sponsored Project Information

Beechcraft Starship Aft Wing Teardown- FAA Sponsored Project Information

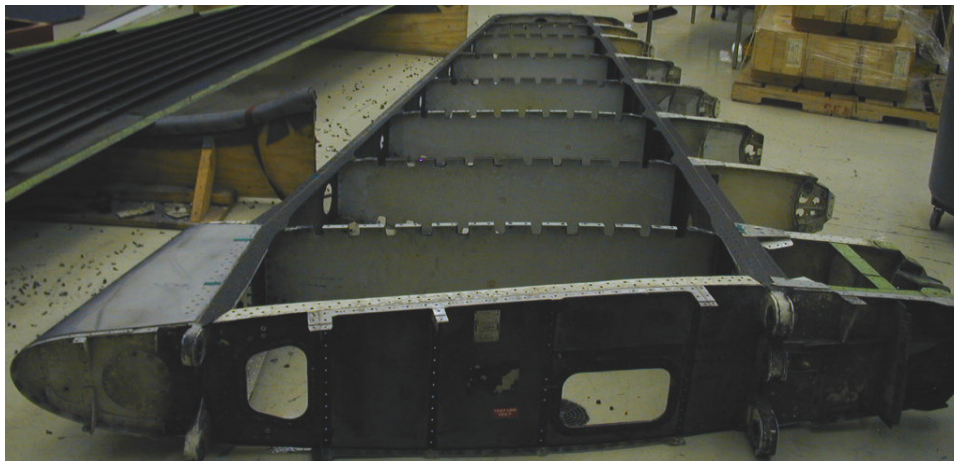
Center Box (RH)

- Structure held very well
- No evidence of pitting or corrosion as would be observed in a metal structure

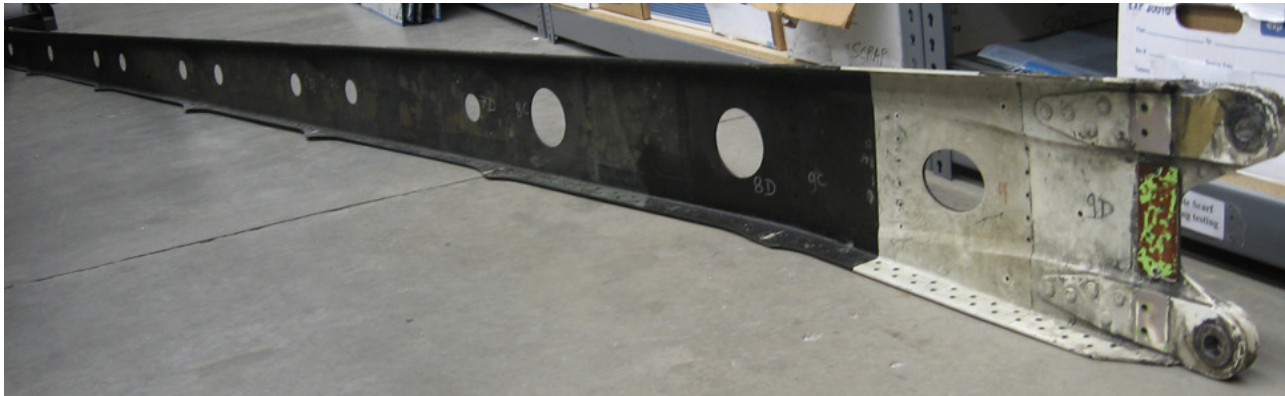
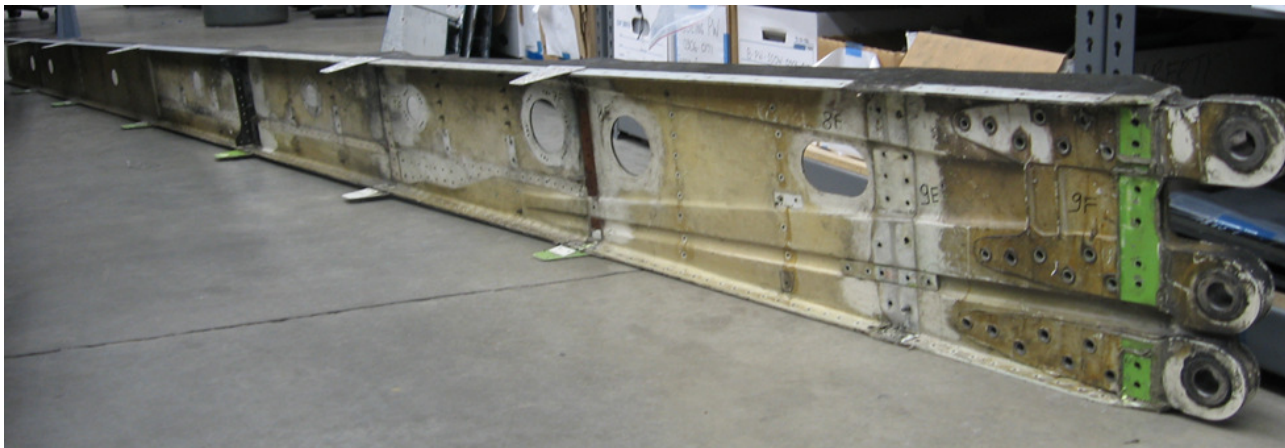
Front (Top) and Rear (Bottom) Spars after disassembly

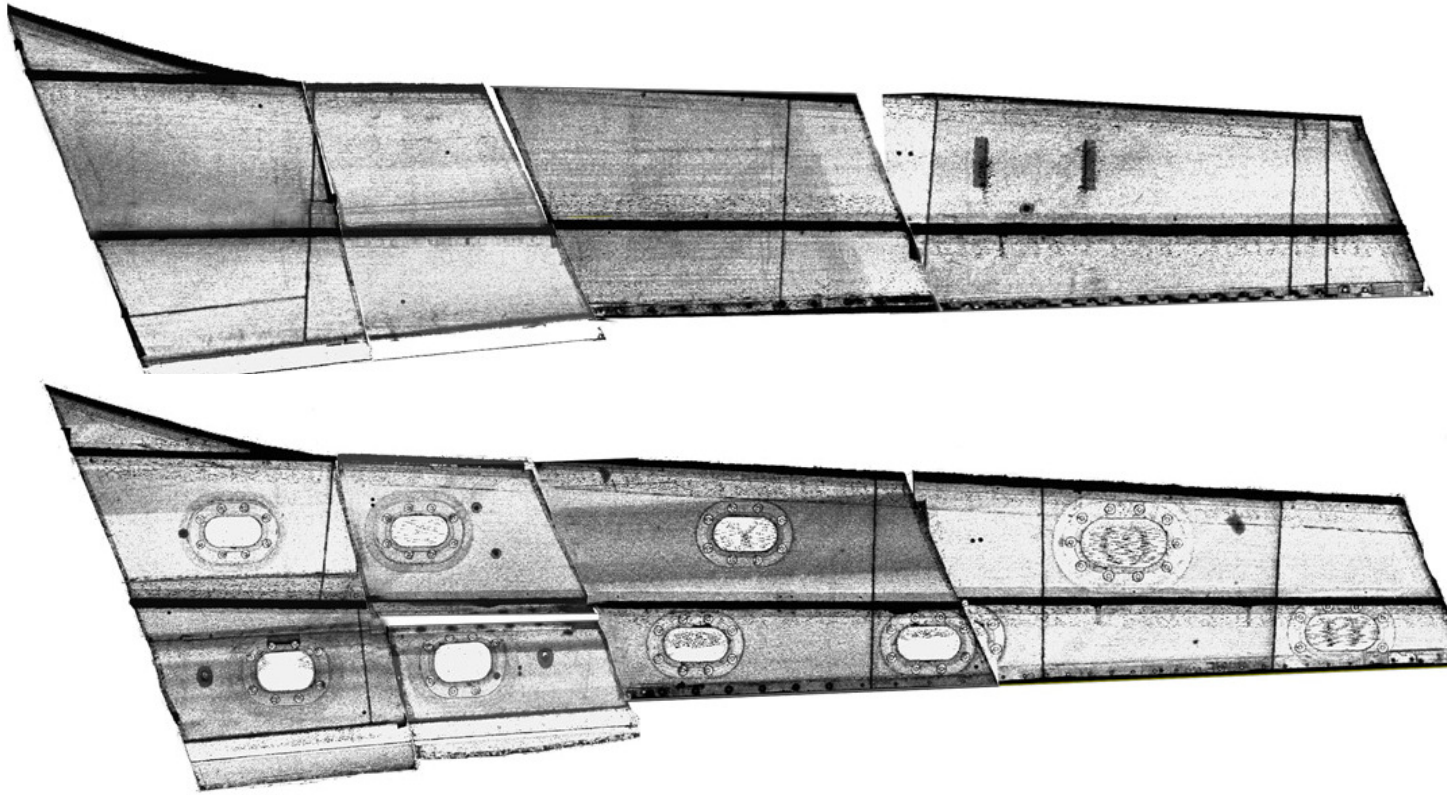
NDI-LH Main Wing

TTU Non-Destructive inspection showed no major flaws induced during manufacture or service in the skins. OEM records suggest that porosity levels in the upper skin flanges exceed 2.5%

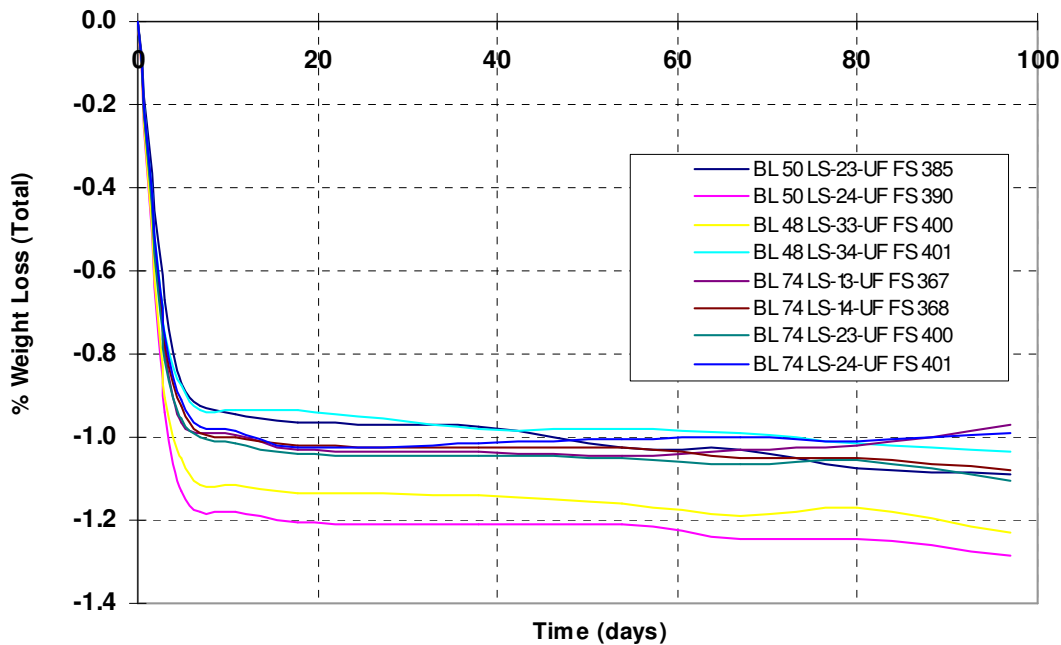
Moisture Content - Lower Skin Upper Facesheet

Maximum Moisture content
 ~1.065% for US and ~1.286% for LS

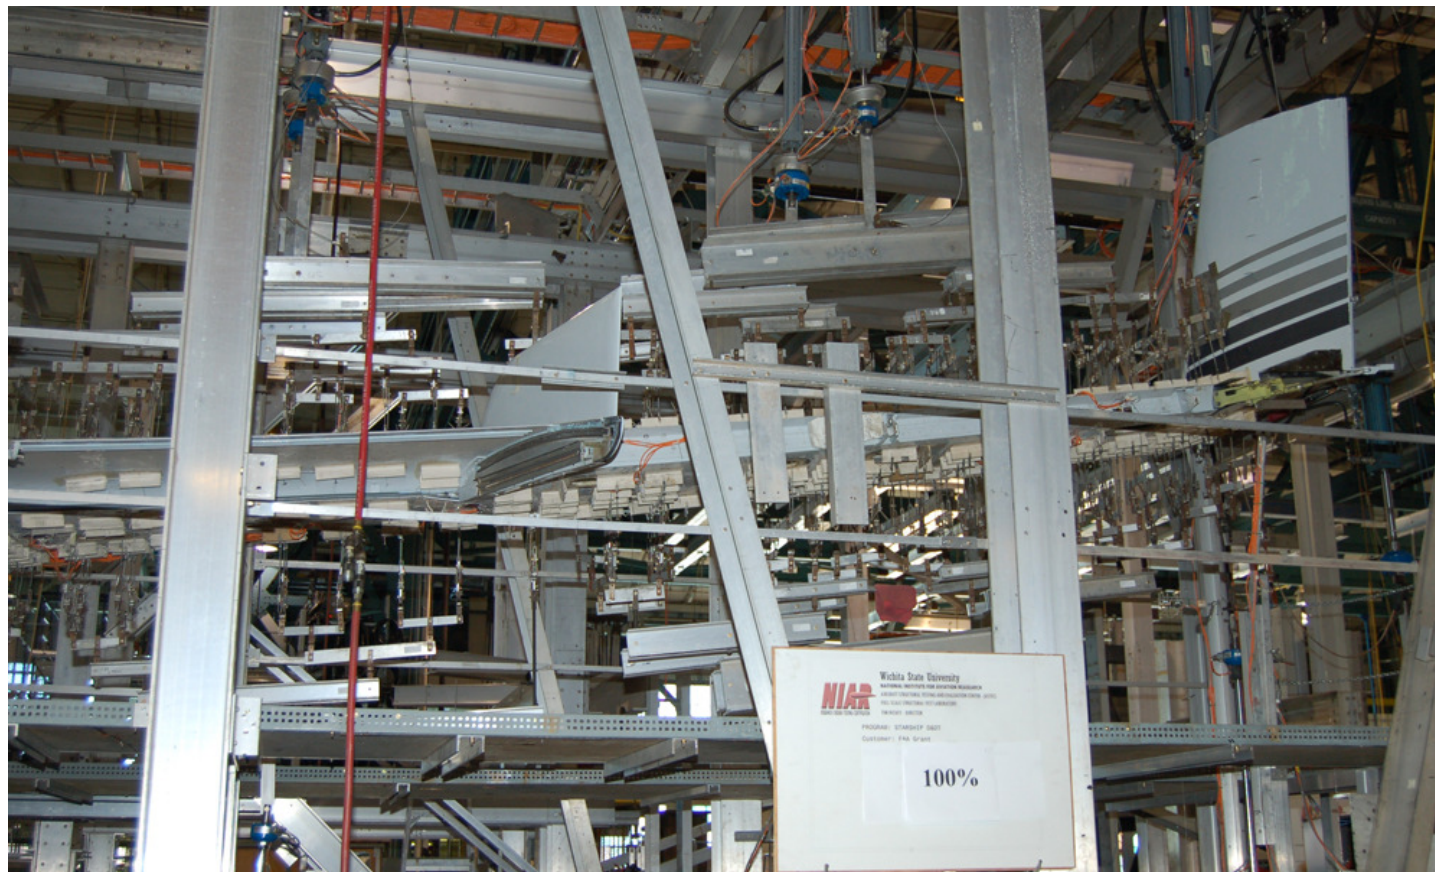
- Strain vs % LL comparison between current test and wing max upbending certification test (Cond 4A)
- No major change in compliance, certification data correlates very well with aged structure limit load test results (data linear to limit load)
