Post-Crash Fire Forensic Analysis on Aerospace Composites

JAMS Technical Review
September 23, 2021

Federal Aviation
Administration

Joint Centers of Excellence for Advanced Materials

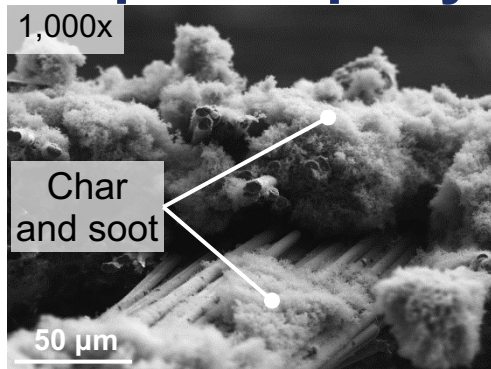
Post-Fire Exposure Fractography of Graphite/Epoxy *UNC0* Specimen Fracture Surfaces

V-12 s fire exposure

V-36 s fire exposure

V-60 s fire exposure

H-15 s fire exposure

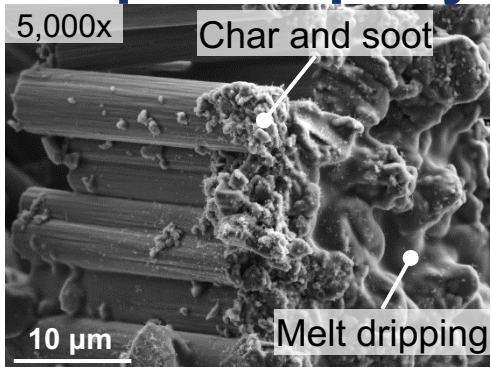
Post-Fire Exposure Fractography of Graphite/Epoxy SBS Specimen Fracture Surfaces

V-12 s fire exposure

V-36 s fire exposure

V-60 s fire exposure

H-15 s fire exposure

H-45 s fire exposure

H-75 s fire exposure

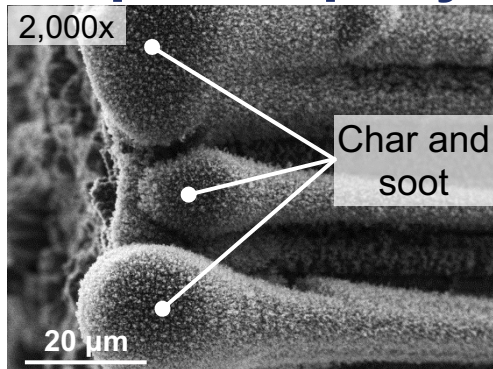
Post-Fire Exposure Fractography of Graphite/Epoxy *IPS* Specimen Fracture Surfaces

V-6 s fire exposure

V-12 s fire exposure

V-36 s fire exposure

V-60 s fire exposure

H-15 s fire exposure

H-75 s fire exposure

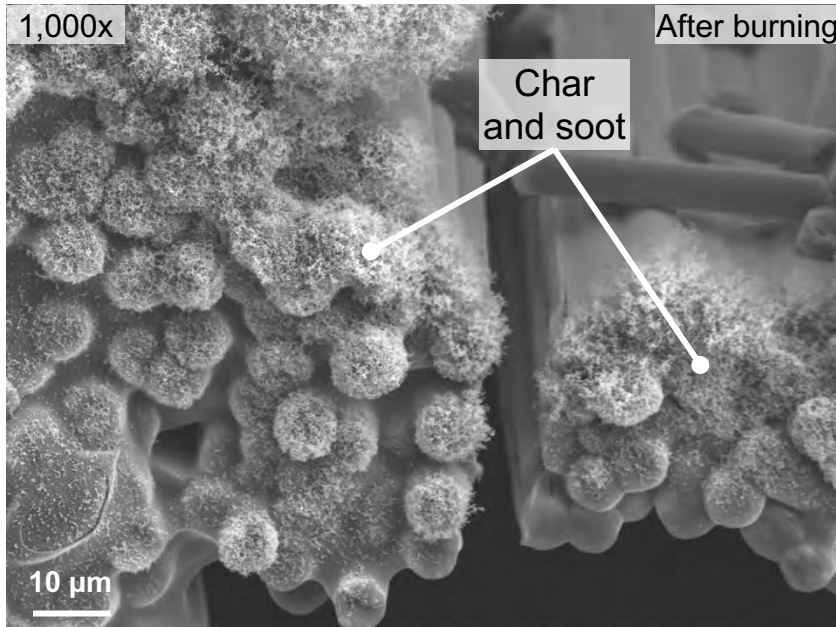
Sulfuric/Nitric Acid Immersion: **Pristine** Burned Hexcel Carbon/Epoxy Specimen

V-12 s fire exposure

Immersion parameters: T=75 °C, t = 60 min

Acid volume: 30 ml, and acid composition: conc.{96-98%} H₂SO₄ + 2 drops of 30%vol. HNO₃

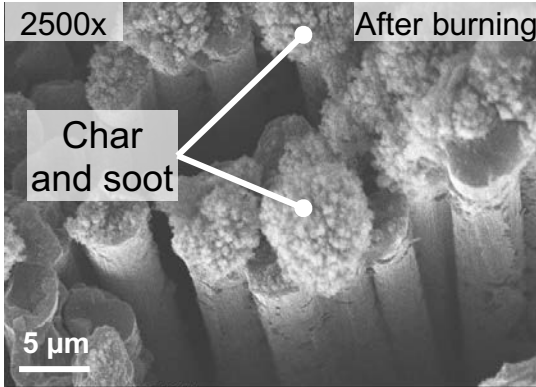
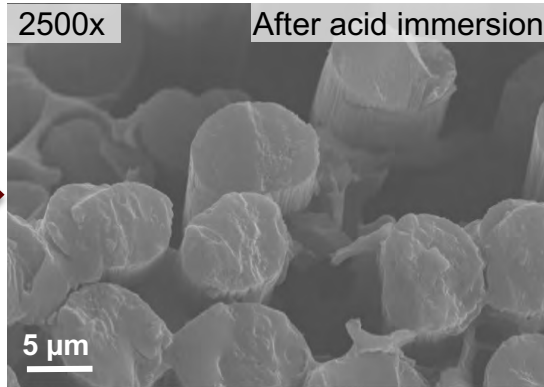
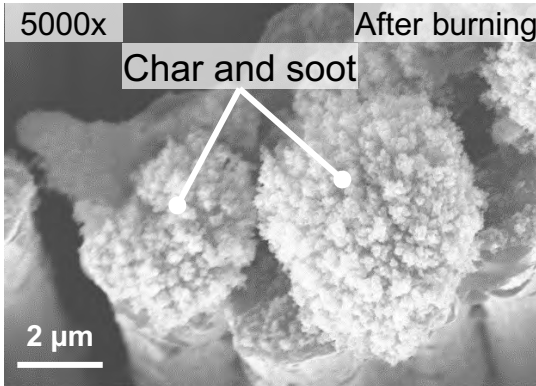
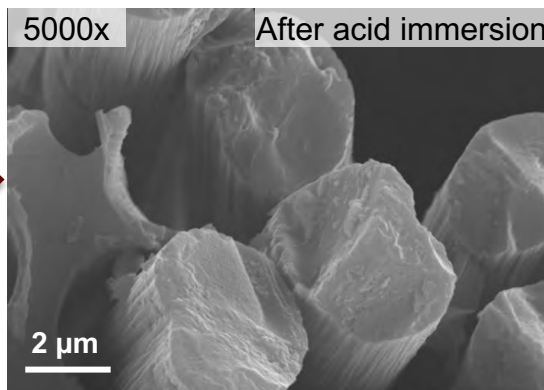
Burned Cytec Graphite/Epoxy $UNC0$ Specimen Before and After Sulfuric/Nitric Acid Immersion

Acid volume: 30 ml, and acid composition: conc. {96-98%} H_2SO_4 + 2 drops of 30%vol. HNO_3

V-12 s fire exposure

Immersion parameters:
T=200 °C, t = 30 min

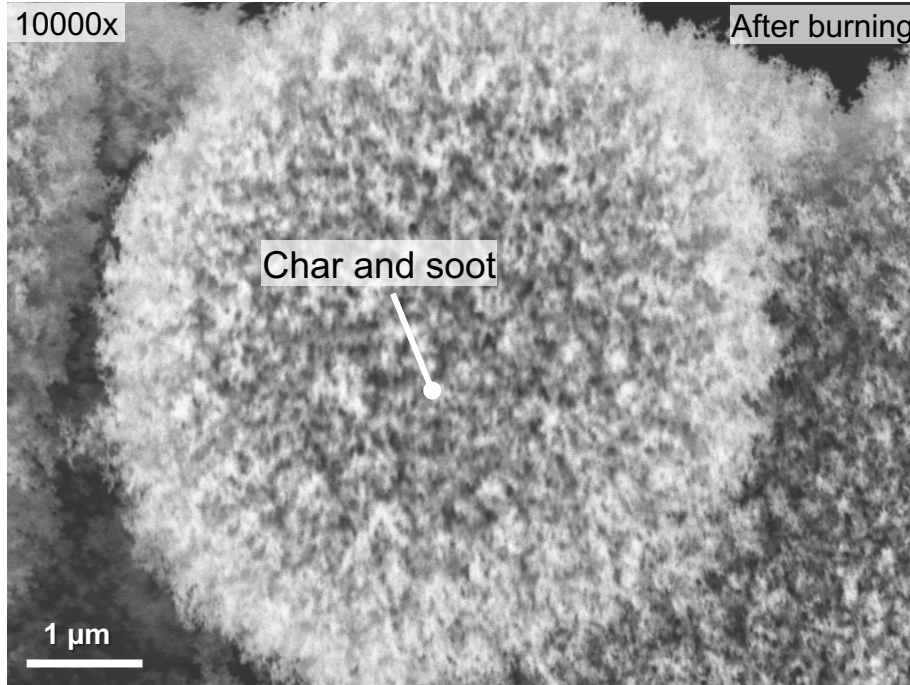
Burned Cytec Graphite/Epoxy $UNC0$ Specimen Before and After Sulfuric/Nitric Acid Immersion

V-12 s fire exposure

Immersion parameters: $T=200\text{ }^{\circ}\text{C}$, $t = 30\text{ min}$

Acid volume: 30 ml, and acid composition: 30 ml of conc. {96-98%} H_2SO_4 + 2 drops of 30%vol. HNO_3

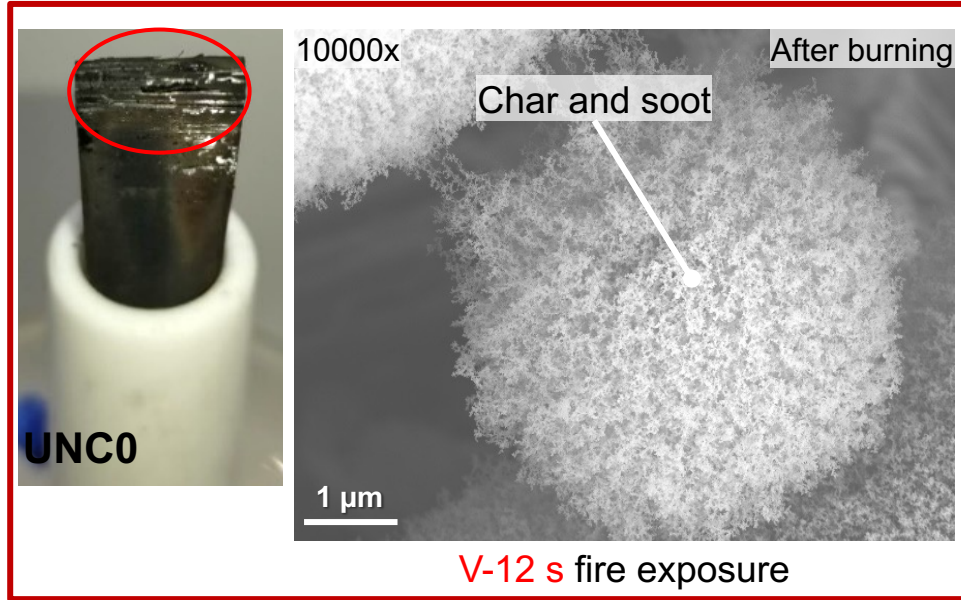
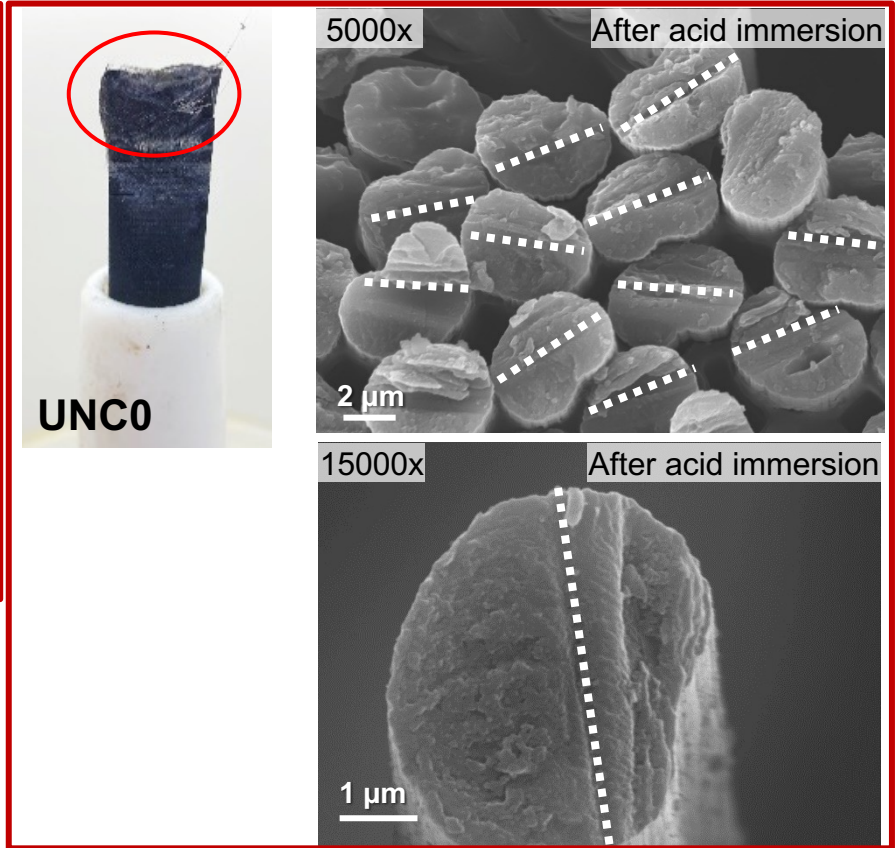
Burned Cytec Graphite/Epoxy UNC0 Specimen Before and After Acid Immersion- {45%} HNO₃

Immersion parameters: T=200 °C, t = 5 min

Acid volume: 30 ml, and acid composition: 95 wt.% conc.{96-98%} H₂SO₄ + 5 wt.% {45%} HNO₃

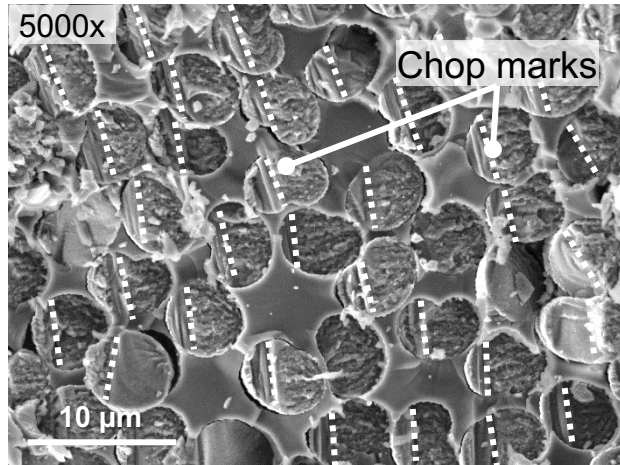
Surface Characterization of **Cytec** Graphite/Epoxy UNC0 Specimen: **Before/After Burn Test and Char Removal**

Before fire exposure

After **V-12 s** fire exposure

After Immersion $T=200\text{ }^{\circ}\text{C}$, $t = 5\text{ min}$

Acid volume: 30 ml, and acid composition: 95 wt.% conc. {96-98%} H_2SO_4 + 5 wt.% {45%} HNO_3

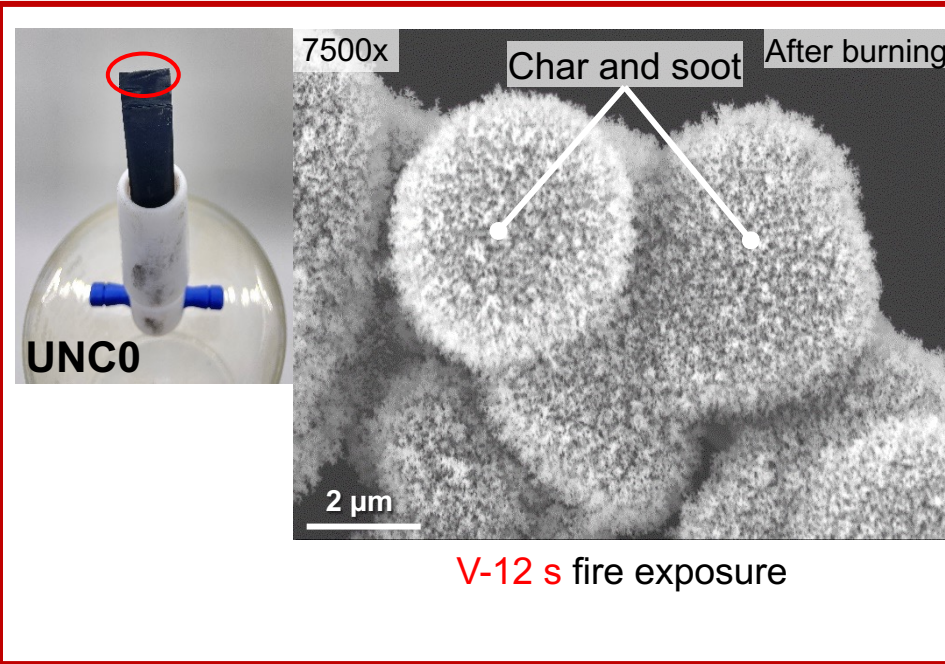
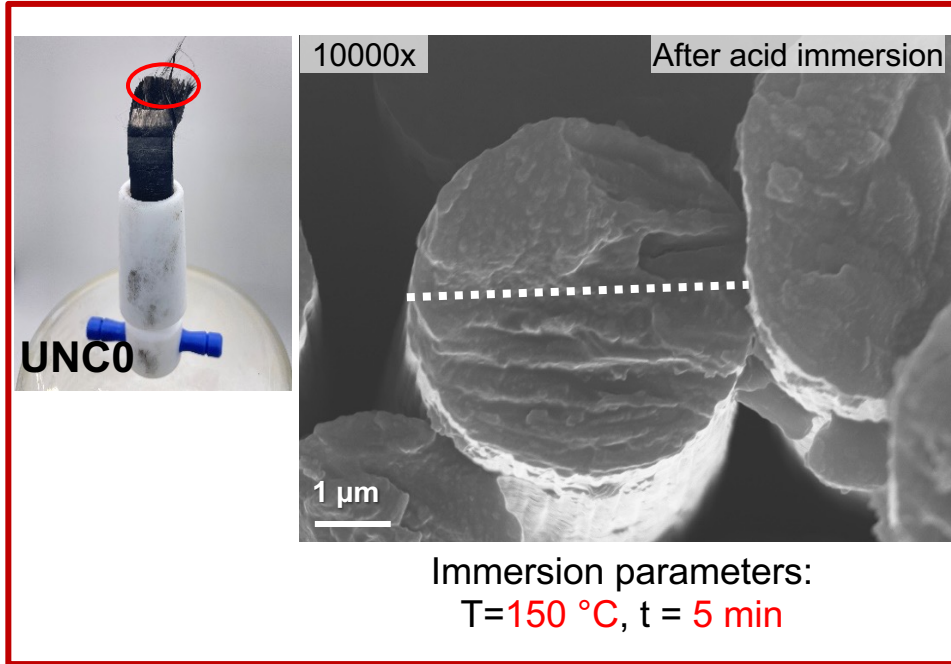
Burned Cytec Graphite/Epoxy UNC0 Specimen Before and After Acid Immersion- {60%} HNO₃

Changing acid composition and amount of nitric acid allowed complete char removal after 5 min immersion

acid composition: 95 wt.% conc.{96-98%} H₂SO₄ + 5 wt.% {60%} HNO₃

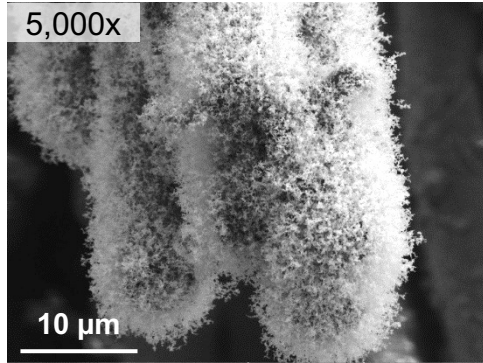
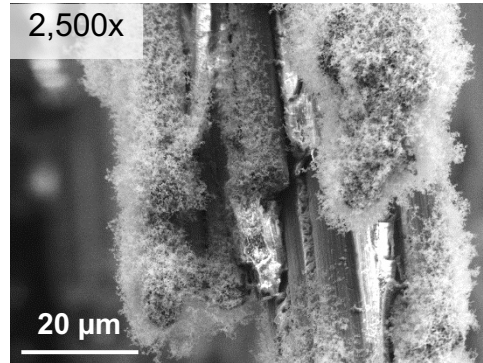
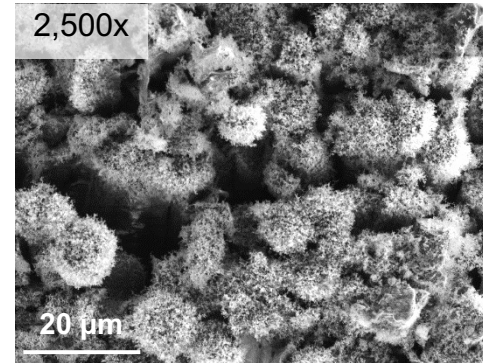
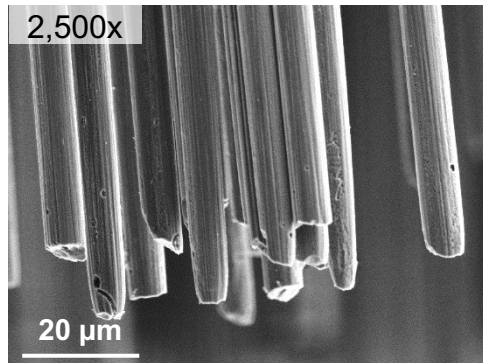
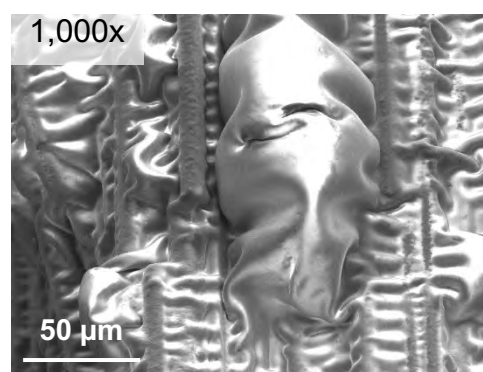
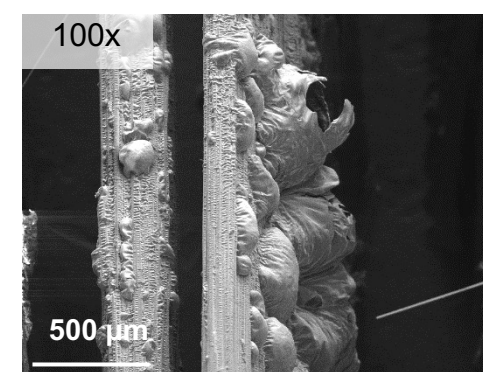
Post V-60s Fire Exposure Fractography of Mechanically Failed PRSEUS Carbon-Epoxy Open Hole Specimen

OH V-60s

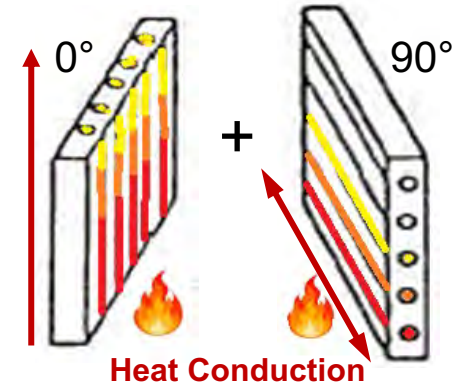
UNCO Specimens: 0° Plies Burned Parallel to the Fibers, 90° Plies Burned Perpendicular to the Fibers

- 0° Plies: Exhibit similar mechanisms as mentioned above
- 90° Plies: Act like a **thermal protection layer** that can **impede (slow)** heat transfer to the interior of the specimen.
 - Conduct heat **parallel to the fire-exposed surface** (along fiber axis)
 - Promote decomposition and combustion of the epoxy matrix **parallel to the fibers**
 - Increase melt dripping and char deposition at the lateral edge of composite
- Difference in ply-orientation increases thermally induced-strain and temperature gradients
 - More delamination, ply-splitting, matrix cracking
 - Provide pathway for outgassing
 - **Less** residual thickness increase

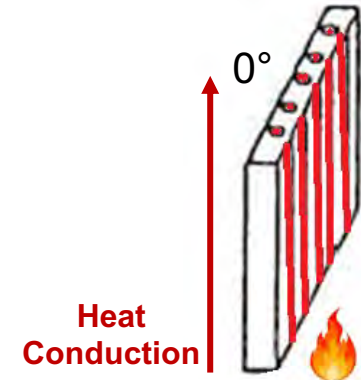
SBS Specimens: 0° Plies burned Parallel to the fibers

- Conduct heat **perpendicular to the fire-exposed surface** to the interior of the composite
- Promote formation and deposition of:
 - Melt dripping
 - Internal pockets of matrix decomposition
 - Surface char deposition
- Promote development of new matrix cracks and fissures to accommodate explosive outgassing resulting in **significant** residual thickness increase

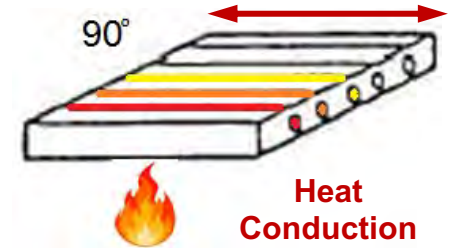
UNC0 Specimens: Outer 90° Plies Burned Perpendicular to the Fibers

- 90° Plies: Act like a thermal protection layer that can impede (slow) heat transfer to the interior of the specimen.
- Conduct heat parallel to the fire-exposed surface (along fiber axis)
- Less heat conduction and thermal damage through-the-thickness

Heat transfer due to convection of hot gasses and smoke bypass the specimen causing less severe fire damage in both specimens

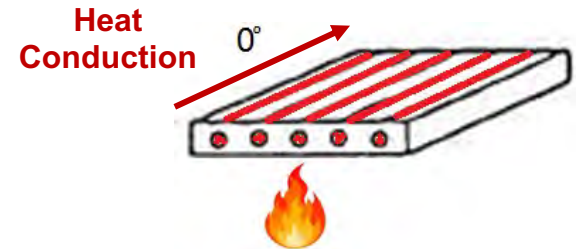
SBS Specimens: Outer 0° Plies burned Perpendicular to the fibers

- Conduct heat perpendicular to the fire-exposed surface to the interior of composite
- Promote formation, decomposition and combustion of the epoxy matrix along the primary heat conduction path (parallel to the fibers)
- Less heat conduction and thermal damage through-the-thickness

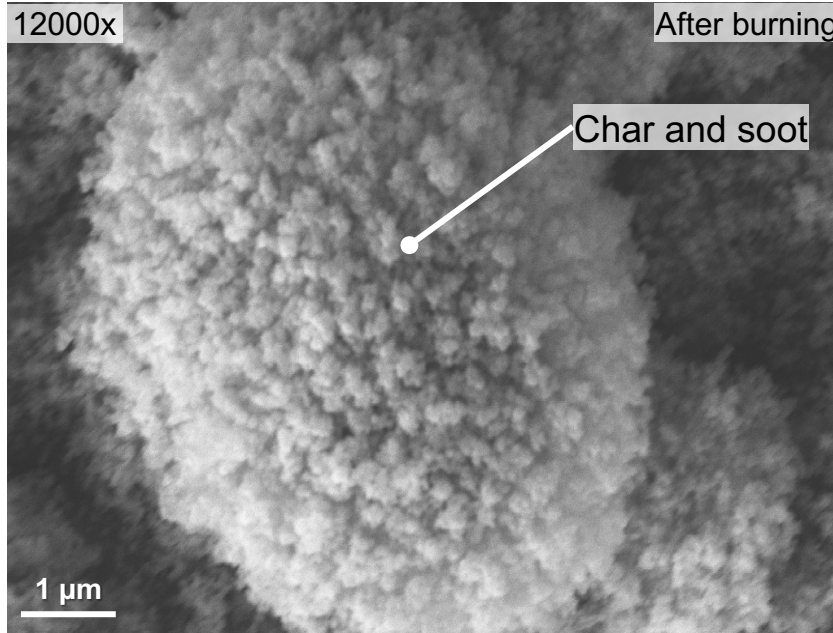
Pristine Burned Cytec Graphite/Epoxy Specimen Before and After Sulfuric/Nitric Acid Immersion

V-12 s fire exposure

Immersion parameters: T=200 °C, t = 30 min

Acid volume: 30 ml, and acid composition: 30 ml of conc.{96-98%} H₂SO₄ + 2 drops of 30%vol. HNO₃

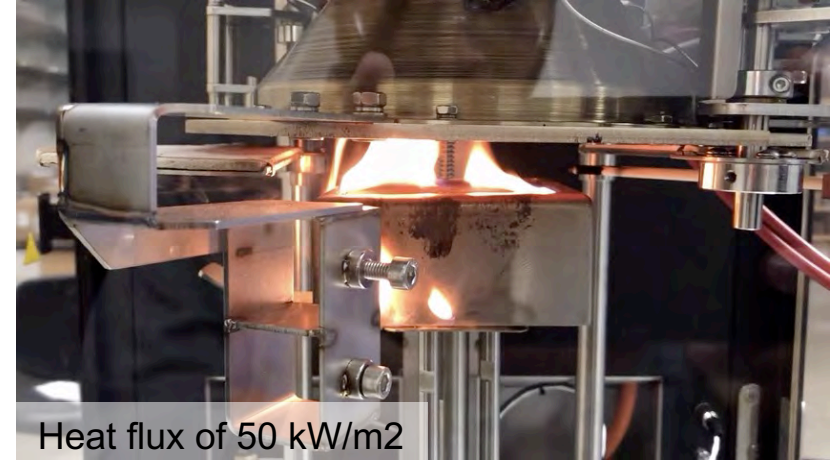
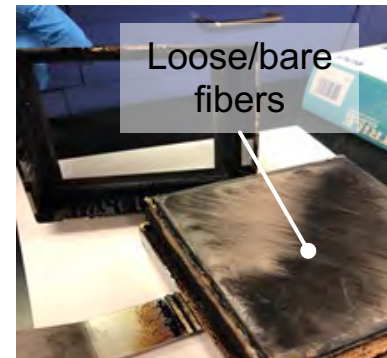
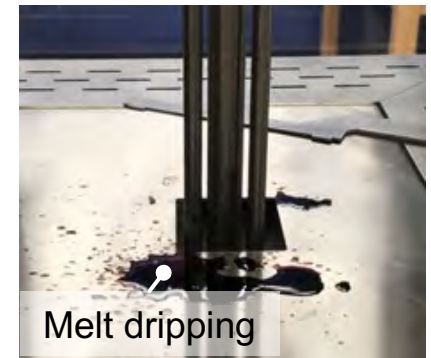
Cone Calorimeter Test of CAI Specimen

- **Large-scale matrix decomposition** throughout the entire specimen
 - No epoxy matrix or char were visible
 - Thermal-based approach may be efficient at removing char from burned specimens
- Broken and micro-buckled fibers at the CAI failure plane virtually indistinguishable from the surrounding fibers
- **Large-scale multi-ply-delamination**
- Large amounts of **melt dripping** from specimen edges
 - Viscous tar-like substance that solidified after cooling
