Inspection and Teardown of Aged In-Service Bonded Repairs

2016 Technical Review

Waruna Seneviratne, John Tomblin, and Brandon Saathoff

NATIONAL INSTITUTE
FOR AVIATION RESEARCH

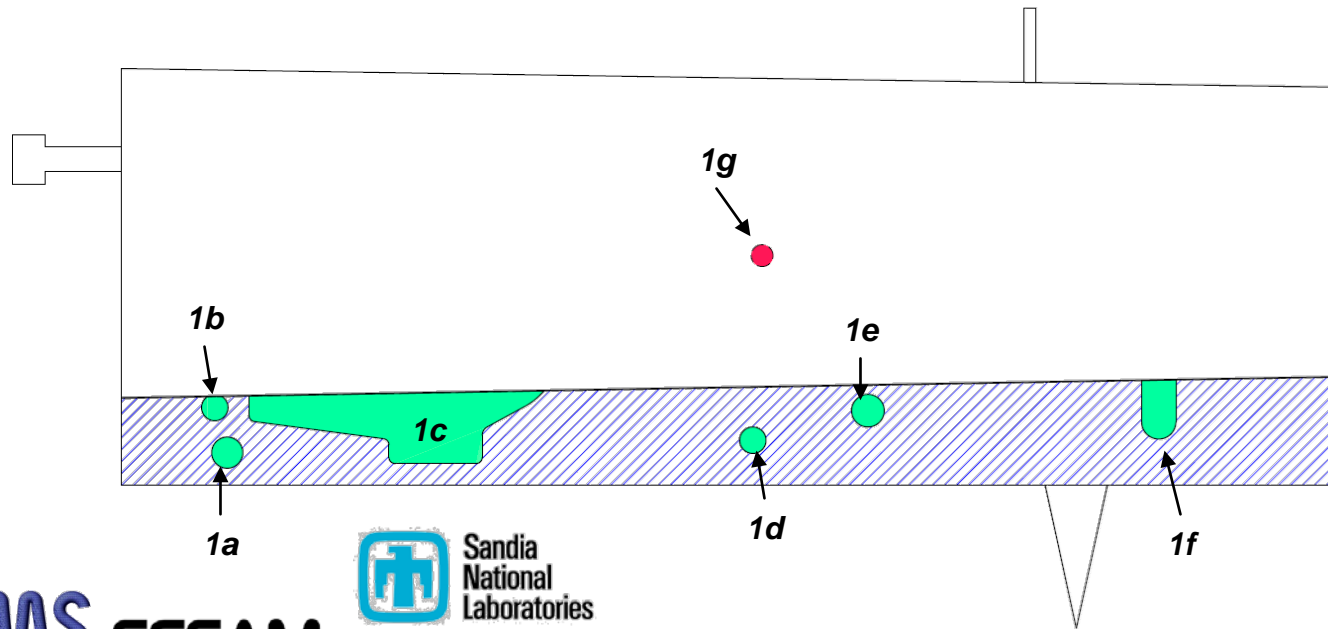
Component 1 – B767-300 I/B Flap (RH)

- Top Skin Repair
- Bottom Skin Repair
- Bottom Skin Disbond
- Extraction Region

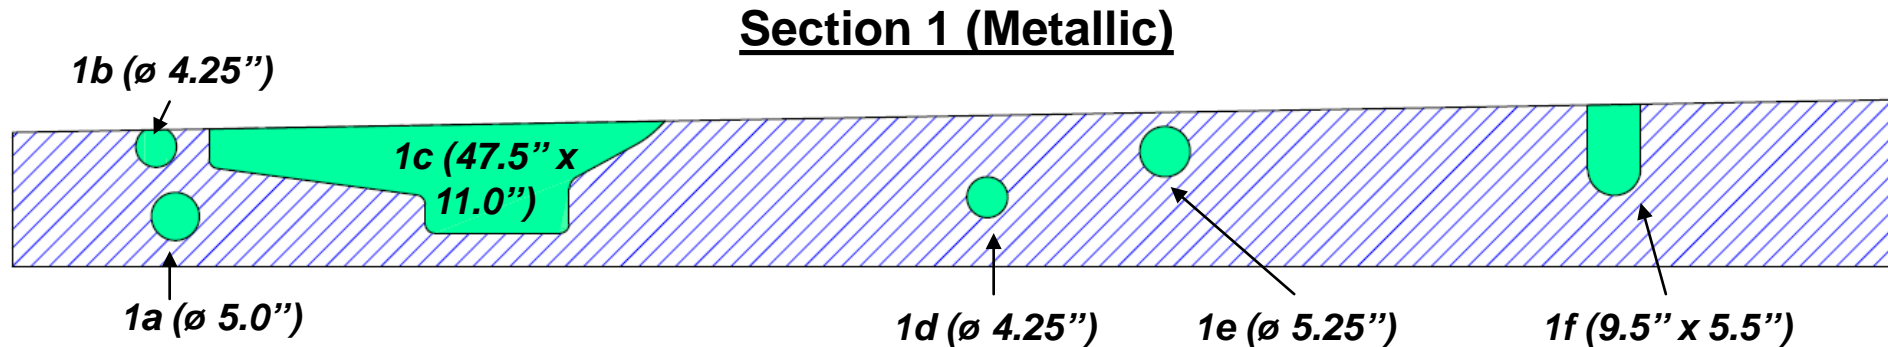
Component 1 – Subpanel Extraction (Metallic)

- *Need to verify if Aramid/Epoxy outer ply exists on lower skin.*
 - *If this is the case, repair 1g will not be considered.*
 - *These repairs have significant curvature near leading edge.*

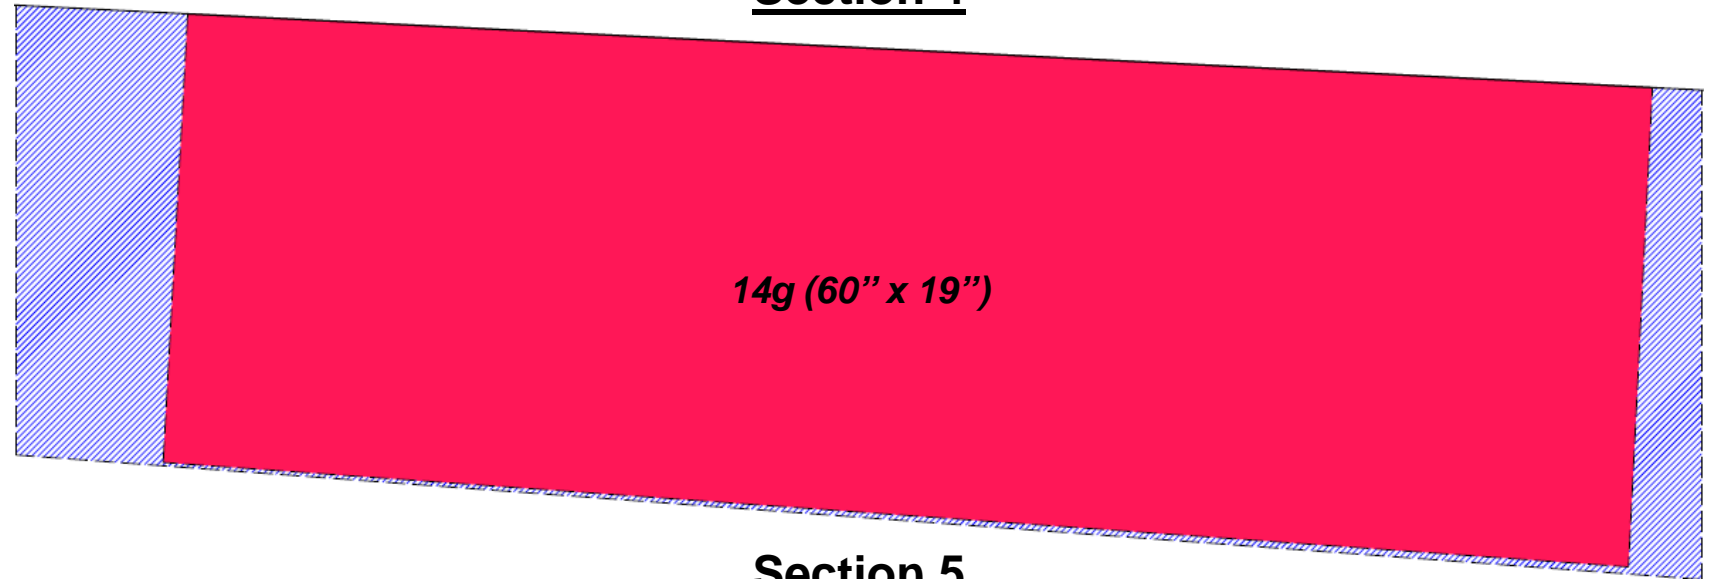
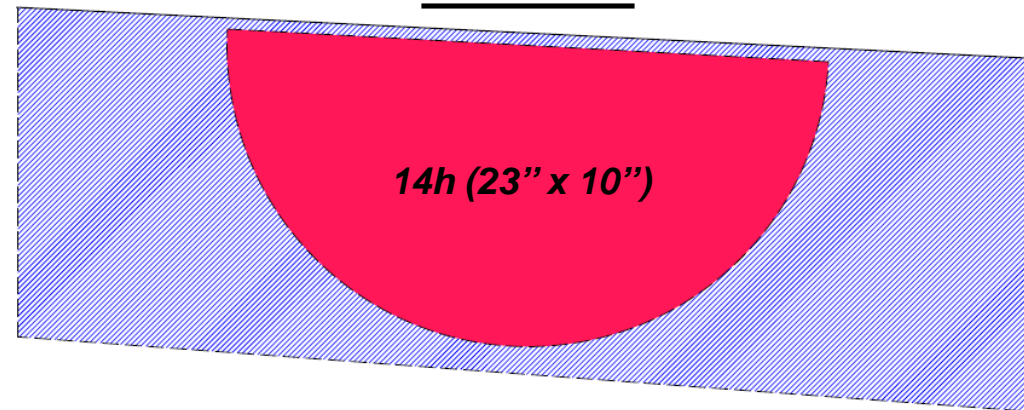
Component 14 - Subpanel Extractions (Composite)

- *Limited repeatability. These materials are not used on any other repairs we have.*
