JOINT ADVANCED MATERIALS & STRUCTURES
CENTER OF EXCELLENCE

Composite Thermal Damage Measurement with Handheld FTIR

April 9, 2013

Brian D. Flinn, Ashley Tracey, and Tucker Howie
University of Washington

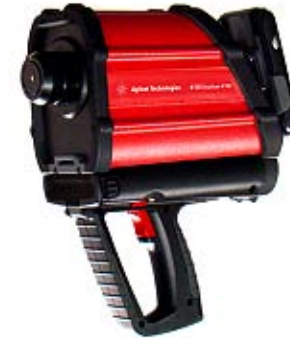
ExoScan FTIR

- Mid-IR data region: 4000 cm^{-1} to 650 cm^{-1}
- Diffuse reflectance sampling interface
- Data collection: 120 coadded scans with 8 cm^{-1} resolution for background and specimen

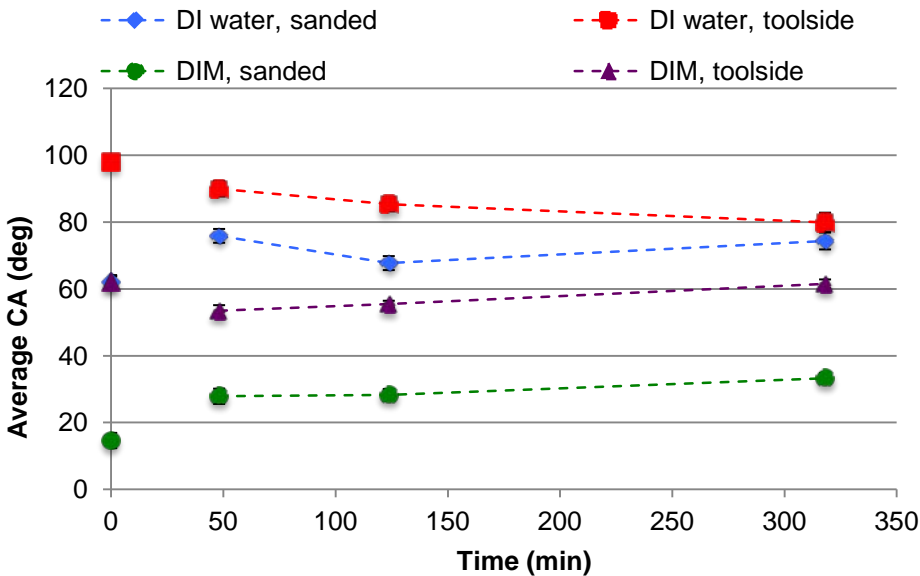
415 F

increasing thermal damage

- CA on sanded surface lower than toolside surface
- No significant correlation between SBS values and CA measurement – 415, 445, 475, 505 °F

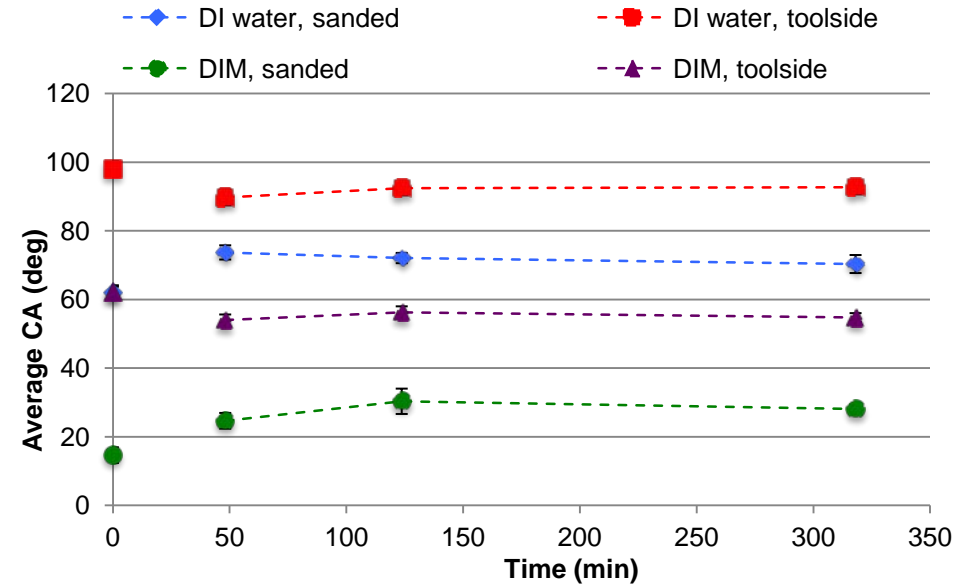
475 F

increasing thermal damage

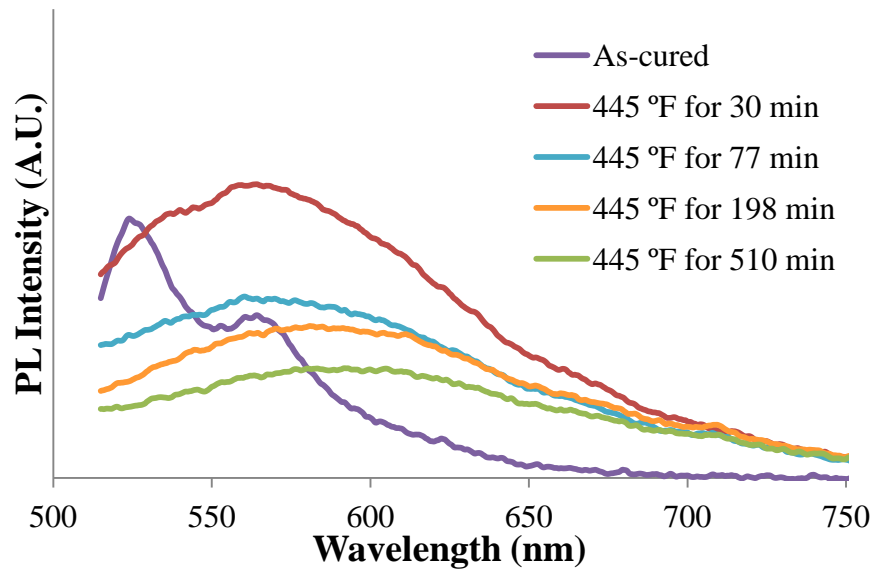
- λ_{MAX} red-shifts and intensity decreases with increasing exposure
 - λ_{MAX} does not monotonically relate to SBS retention
- No fluorescence measurable on sanded surface

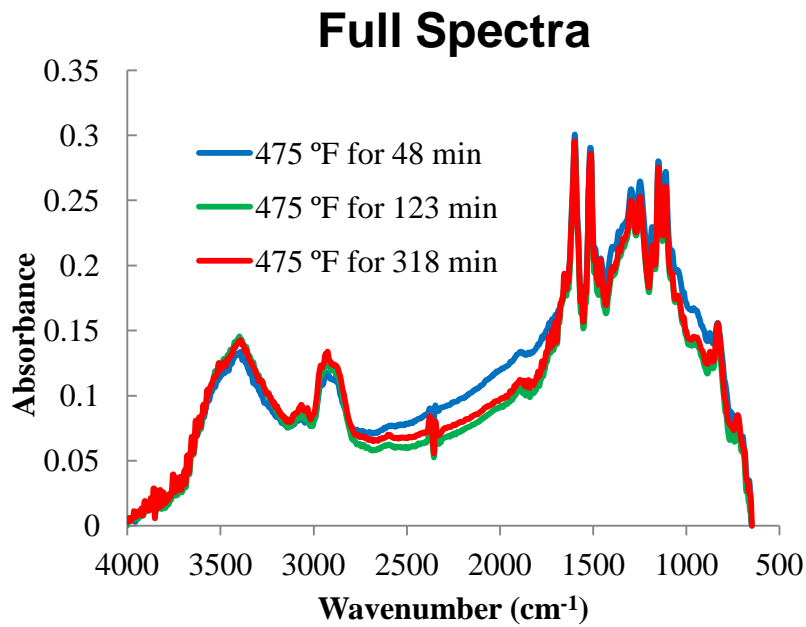
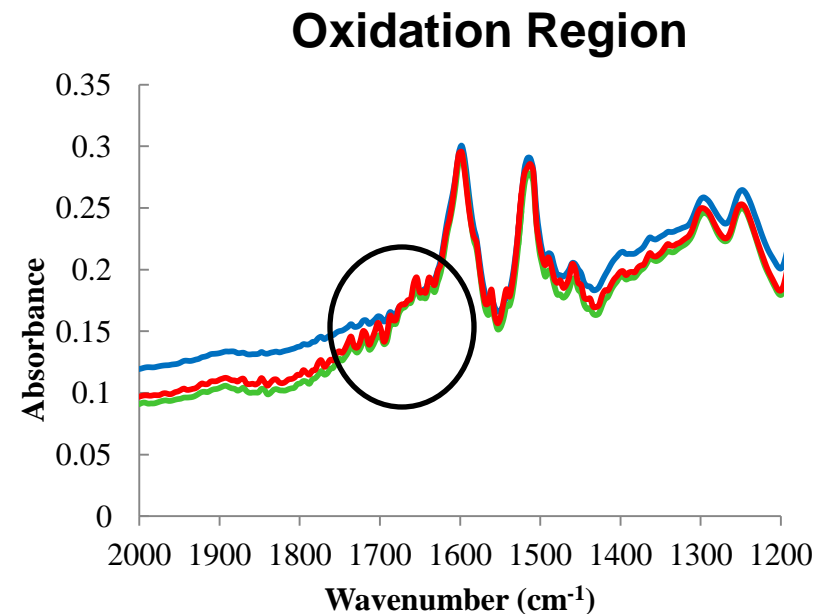
- Damage is not as clear as on toolside surface
 - Oxidation removed by sanding
 - Need multivariate analysis to determine differences in spectra and correlate to SBS data

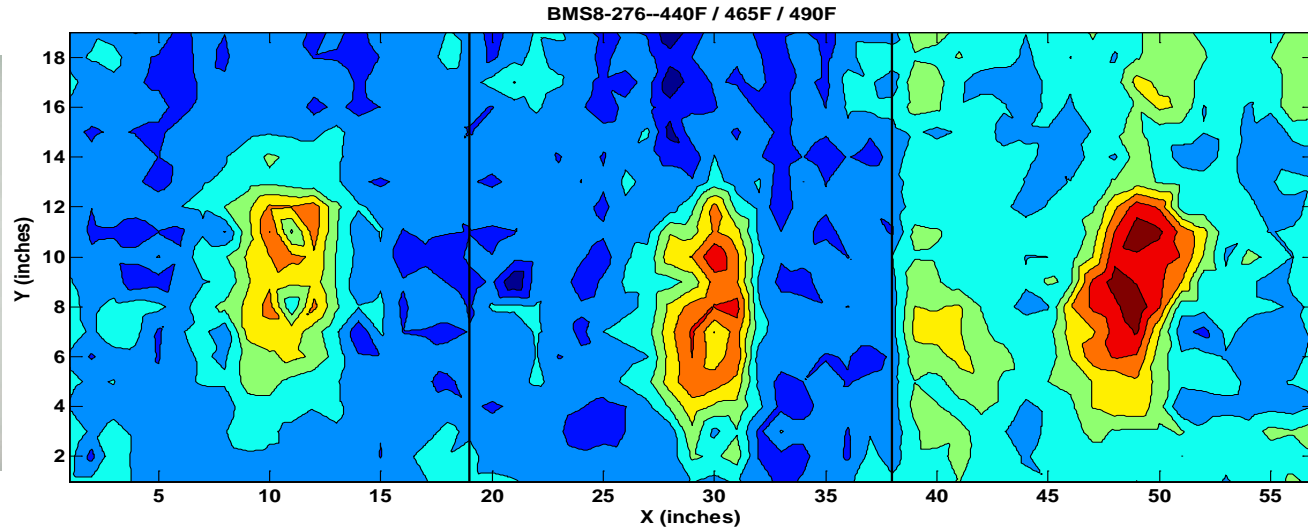
- FTIR Map of Surface Damage
 - Blue is low damage
 - Brown is high damage

Low (440 °F for 1 hr) Medium (465 °F for 1 hr) High (490 °F for 1 hr)
