Evaluation of Aged Structural Bonds on Rotor Blades

JAMS Technical Review
April 2023
Seattle, WA

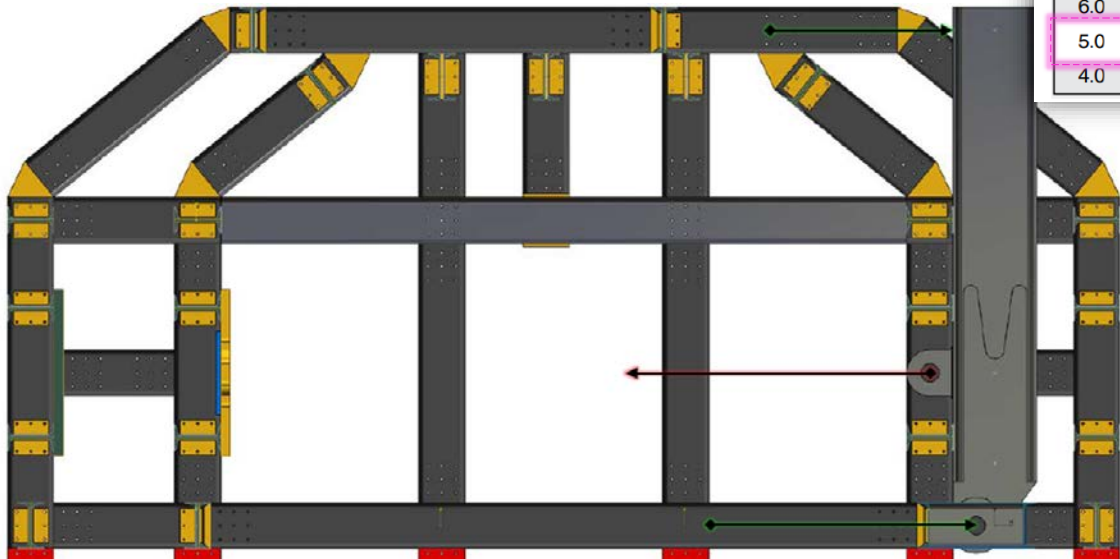
- Fixture Overview
- Centrifugal Force Application

— Class 2 Lever: *Pressurized Air Spring*

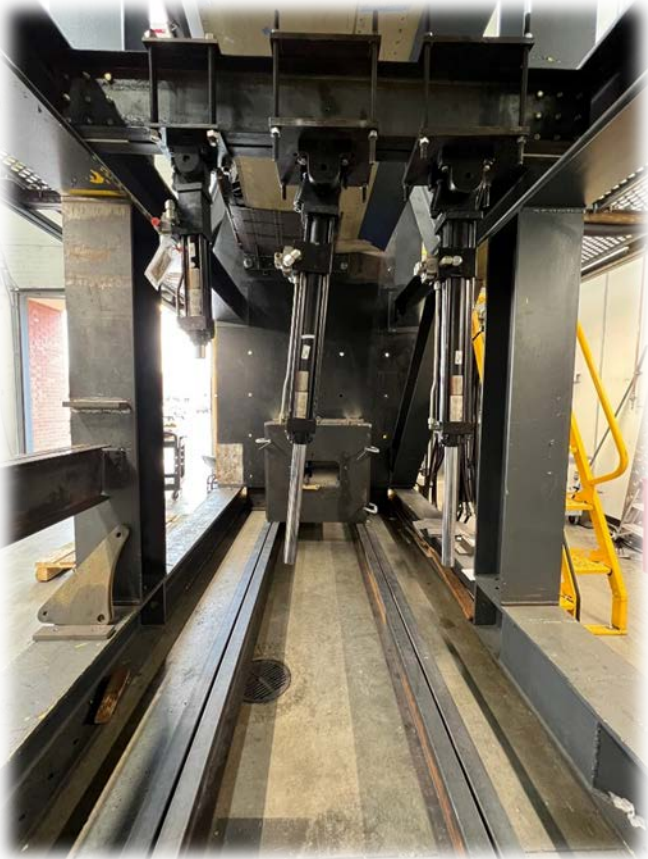
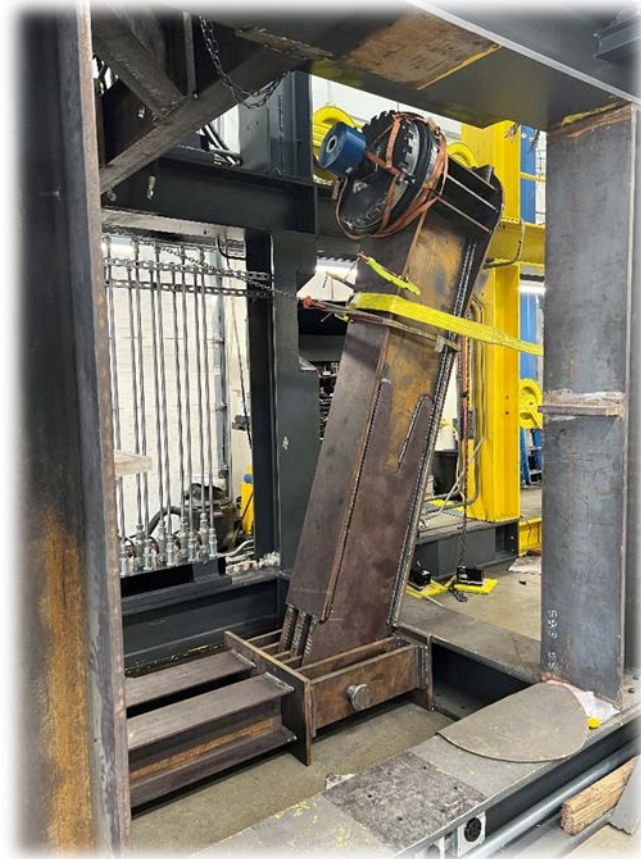
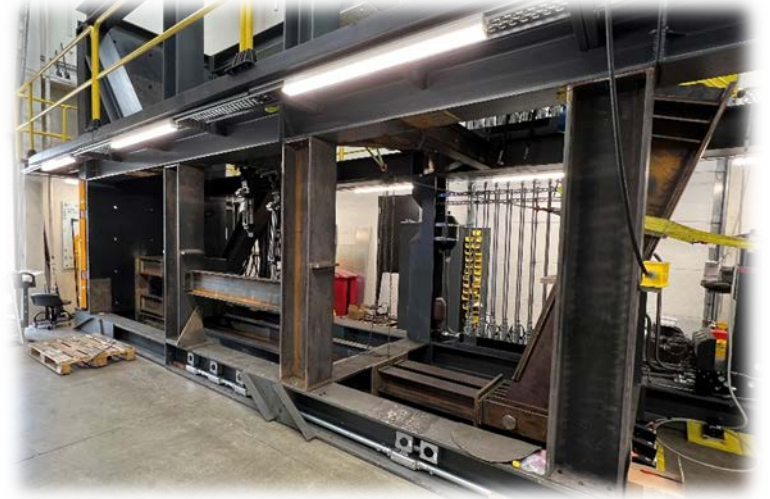
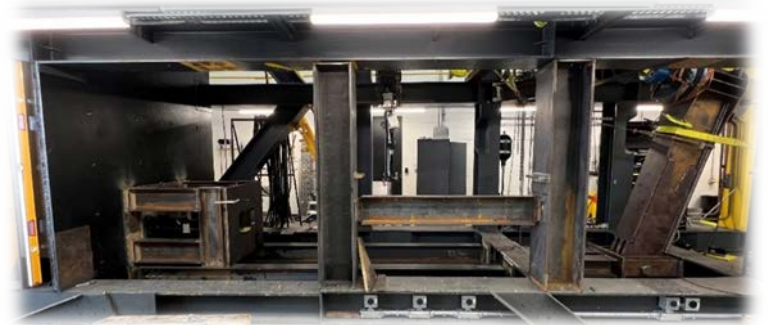
Structural Test Rig Development

Objective: *Establish the capability, and enhance subject matter knowledge, for rotorcraft main rotor blade structural testing efforts at FAA Technical Center and NIAR ATLAS.*

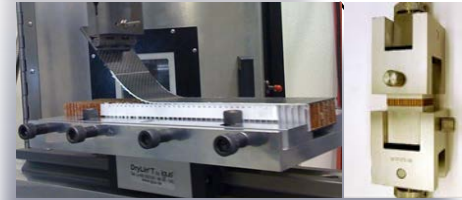
Skin-to-core Bonds

Constituents & Coupons

Upper skin, Lower skin, Upper structural adhesive, Lower structural adhesive, honeycomb core

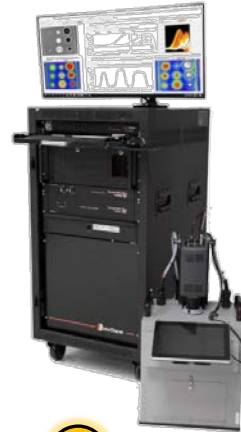
S-76A Inspection

- Pulsed Thermography: X8500 SC Camera

- Resolution: 1280x1024
 - Frequency: 180-Hz

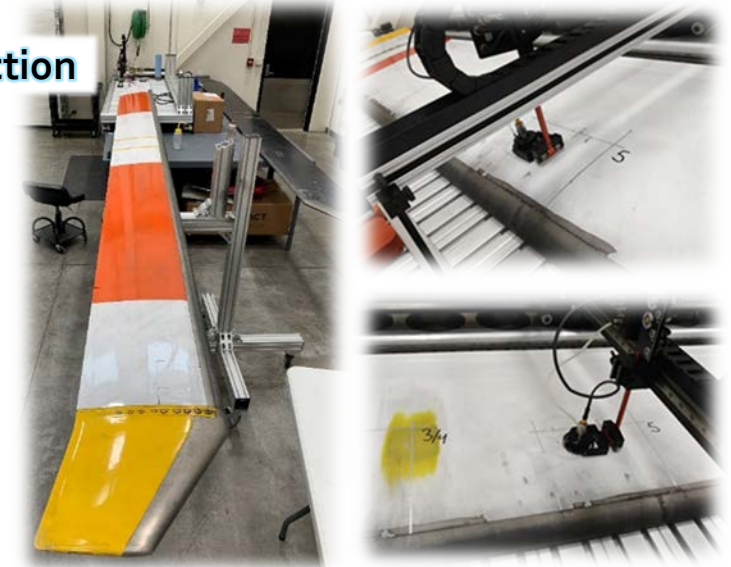
- **Laser Technology Inc. (LTI)**

- Laser Shearography: LTI-2100HP-300

- 300-mW @ 532-nm Green Laser
 - 2-kW Thermal Stress System
 - In-house Vacuum System and Local Chamber

- **NDTS MAUS**

- Pulse Echo UT: Single-element 5.0-MHz
 - Resonance Testing: 270-kHz and 320-kHz
 - Mechanical Impedance Analysis: 19-kHz

- **Thermal Wave Imaging (TWI)**

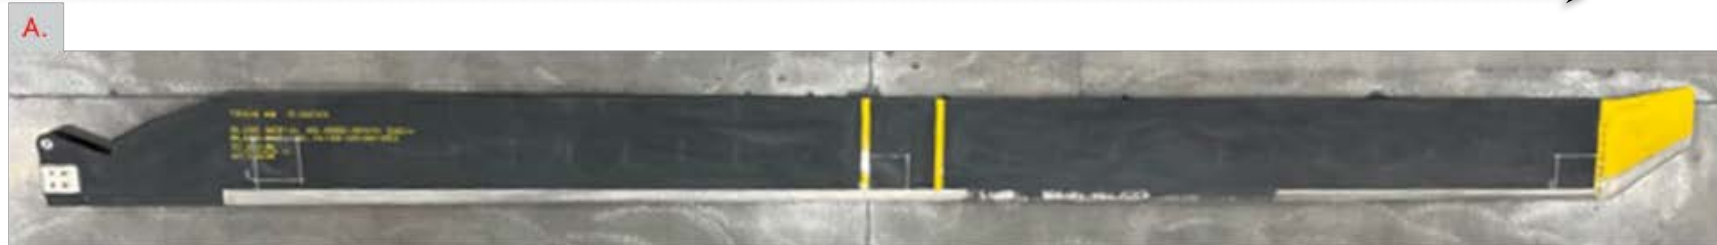
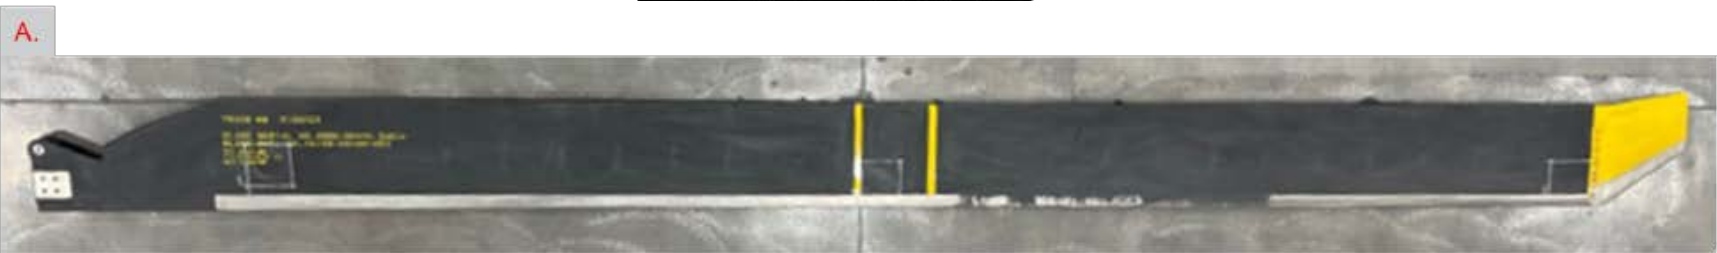
Inspection Reporting

Project Title: Sikorsky Blade End of Life Inspection
Date: Oct 25, 2022

Inspection Type: Thermography, Shearography and Ultrasonic
Inspection Configuration: Helicopter Blade
Material Configuration: Face sheet-Honeycomb composite spar

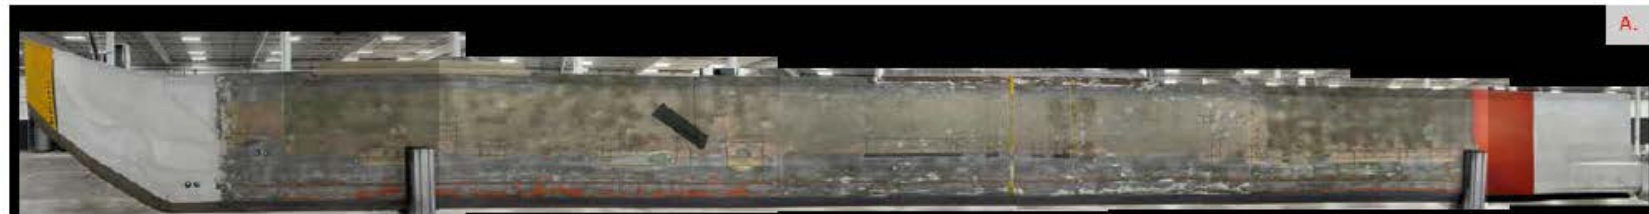
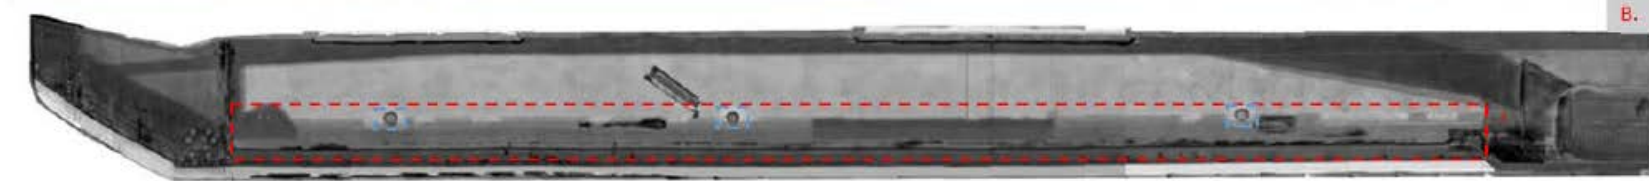
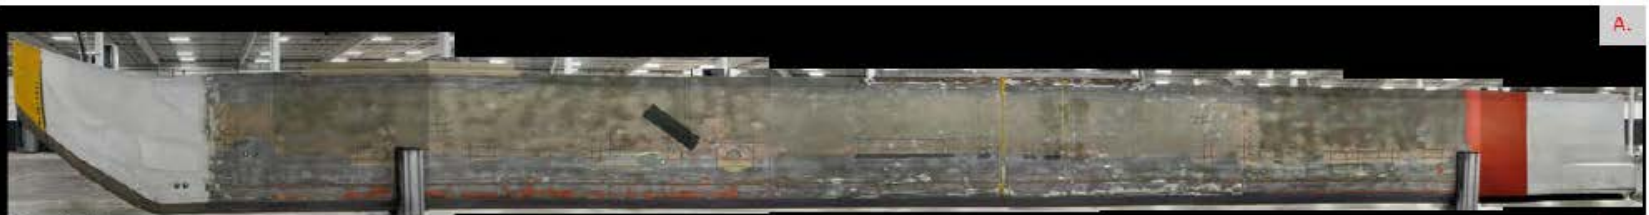
Project Title: Sikorsky S92 Blade End of Life Inspection
Date: Feb 15, 2023

Inspection Type: Thermography, Shearography and Ultrasonic
Inspection Configuration: Helicopter Blade
Material Configuration: GFRP/Honeycomb

- Two identical blades exhibiting vastly different levels of skin-to-core bond strength as determined by OEM in-situ peel testing.
 - Evaluation of operational conditions (environment, flight profiles, etc.).
 - Performance of NDI for receiving condition evaluation and region of interest (ROI) determination (defects/damages).
 - Evaluation of skin-to-core bond characteristics.

Initial NDI Findings: *Utilizing standard inspection techniques, no change from nominal was discernable in severely aged blades.*

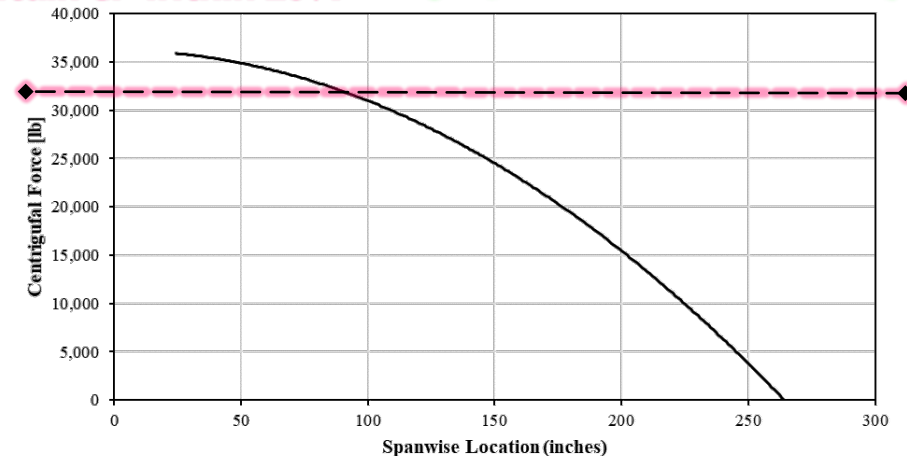
Maintain CF within 10%
