# Char removal strategy for fire-forensic analysis of mechanically-failed aerospace carbon/epoxy composites

**JAMS Project Title:**  
Post-Crash Fire Forensic Analysis on Aerospace Composites

JAMS Technical Review  
April 19, 2023

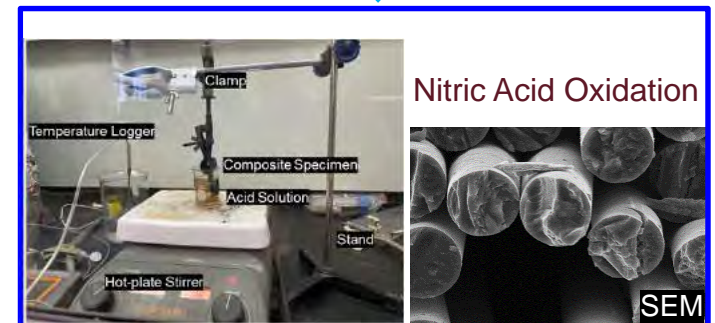
Acid Oxidation: Liquid-phase thermo-oxidative char removal experiments were performed on mechanically failed composites ranging from coupon-scale (NCAMP: UNC0, SBS) to structural-scale (open-hole) samples burned in small-scale bunsen burner fires and pool fires

- Solution type: Sulfuric/nitric solution
- Composition:
  - Sulfuric acid: [82 – 93] wt.%,
  - Nitric acid: [0.9 – 9.32] wt.%,
  - Water: [5.32 – 8.33] wt.%,
- Volume: 30 – 75 ml
- Immersion Time: 45 s – 10 min
- Temperature: 90 – 175 °C
- Stirrer: 60 rpm
