Fluid Ingression Damage Mechanism in Composite Sandwich Structures

Allison Crockett, Wichita State University
Hal Loken, Consultant
John Tomblin, Wichita State University
July 21-22, 2009

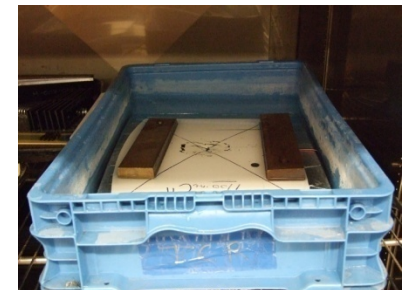
Panel soaking in chamber 180°F

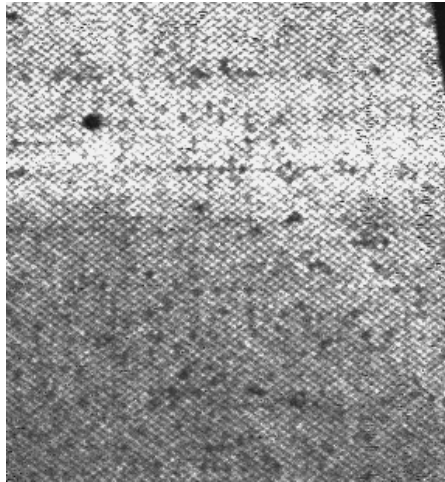
Before Impact

ADAM Panel:CP2-2C

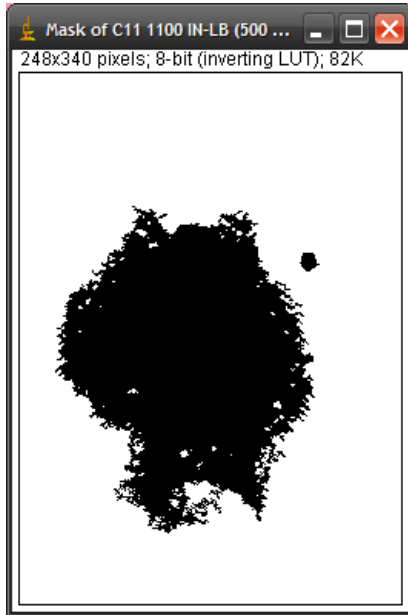
Panel: Starship C11
Impact Energy 1100 in-lb
GAG Cycle Count = 500
Measured Damaged Area = 34.44 in²
