# Evaluation of Aged Bonded Rotor Blades

JAMS 2021 Technical Review

September 22<sup>nd</sup>, 2021

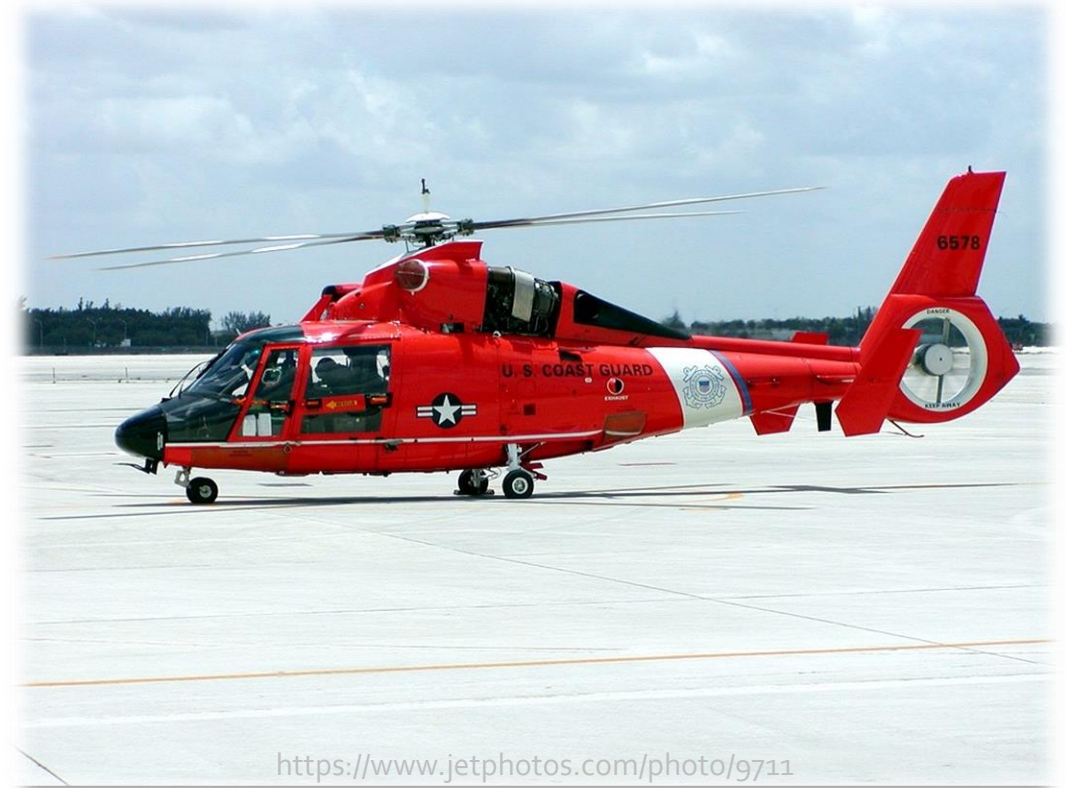
- **Eurocopter HH-65 (Coast Guard)**
  - Entered Service: 1987
  - Blade Time: 10,457.70-hrs
  - End of Service: March 7<sup>th</sup>, 2017
    - Scrapped by the USCG due to rotor over torque to 111.8% and carbon damage at trim tabs out of limits for repair – Obtained from Significant Component History Report
- **Single Main Rotor Blade**
  - Acquired and at NIAR

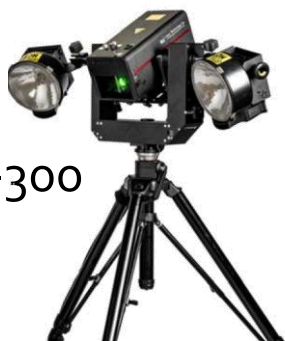
– Laser Shearography: LTI-2100HP-300

- 300-mW @ 532-nm Green Laser
- 2-kW Thermal Stress System
- In-house Vacuum System and Local Chamber

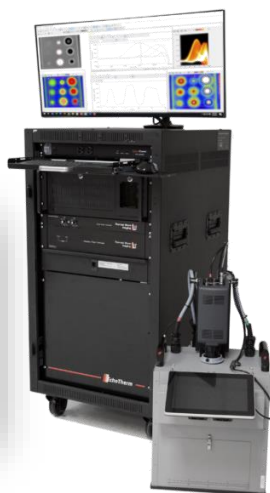
– Pulsed Thermography: X8500 SC Camera

- Resolution: 1280x1024
- Frequency: 180-Hz

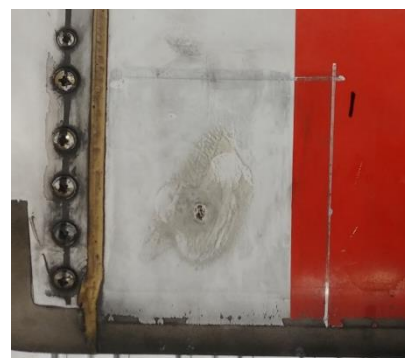
### Indication ID: (1)

Resonance Y: 40809.0, 58622.0  
Resonance X: 39534.0, 53843.0

MIA Y: 36477.0, 61526.0  
MIA X: 43530.0, 60508.0

Amplitude: 9.0 dB, 22.5 dB  
Depth: 0.013 in, 0.056 in

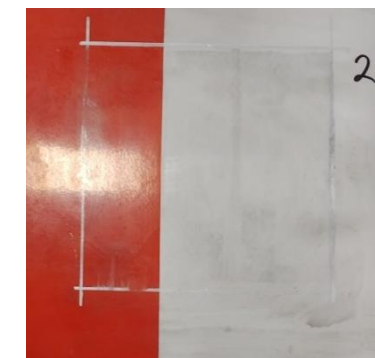
### Indication ID: (2)

Resonance Y: 49049.0, 51324.0  
Resonance X: 48305.0, 50377.0

MIA Y: 47248.0, 49773.0  
MIA X: 47957.0, 50375.0

Amplitude: 9.0 dB, 15.0 dB  
Depth: 0.013 in, 0.038 in

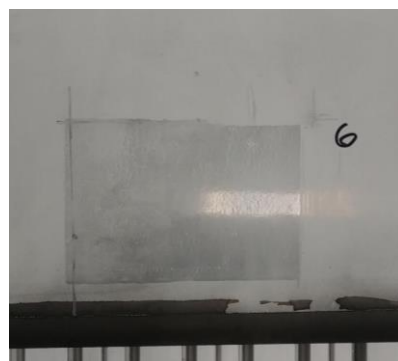
### Indication ID: (6)

Resonance Y

43596.0 54974.0

Resonance X

41925.0 51703.0

MIA Y

45282.0 59319.0

MIA X

46794.0 51439.0

Amplitude

9.0 dB 17.0 dB

Depth

0.013 in 0.038 in

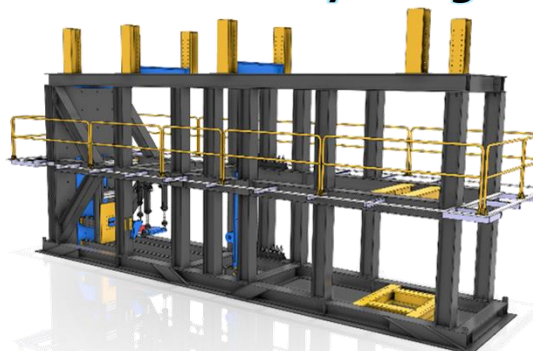
## NIAR ATLAS

- **Aero Load Simulation Through Structural Actuators and Airbag(s)**
  - Five total force inputs (Lift, drag, centrifugal, inboard lead/lag damper replacement)
- **NIAR ATLAS Fixture**
  - Incorporated into large test cell
- **FAA Tech Center Fixture**
  - Standalone for long term testing capability extension
