Aging of Composite Aircraft Structures

John Tomblin, PhD
Executive Director, NIAR

B737-Stabilizer FAA Sponsored Project Information

Beechcraft Starship Aft Wing Teardown- FAA Sponsored Project Information

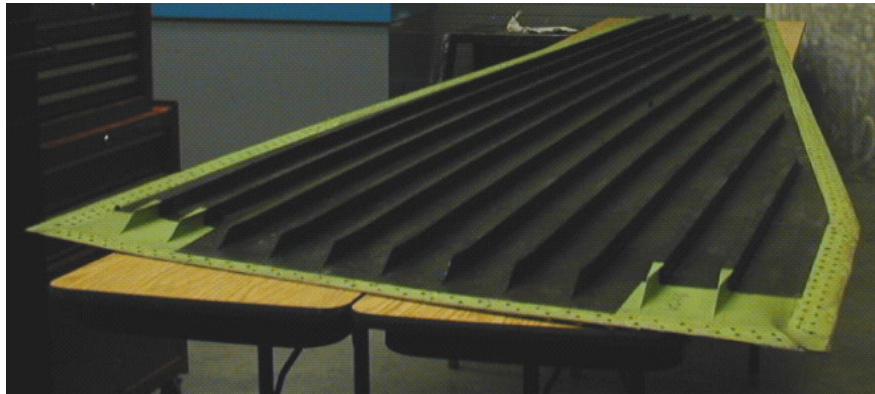
Upper Skin (RH)

- Structure held very well
- No evidence of pitting or corrosion as would be observed in a metal structure

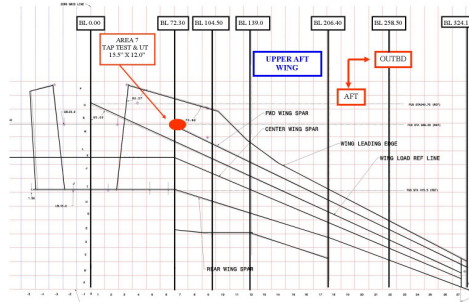
Repair per OEM Specs

- A baseline Non-Destructive Inspection was conducted according to OEM specifications prior to subjecting the structure to limit load (NDI grid has been drawn on the structure for ease of inspection and flaw growth monitoring)
- Visual inspection, TTU and tap testing were used for the inspection
- A few areas in both the upper and lower skins have been identified as disbonds by the inspectors -> identified as potted areas-> areas repaired per OEM prior to limit load test

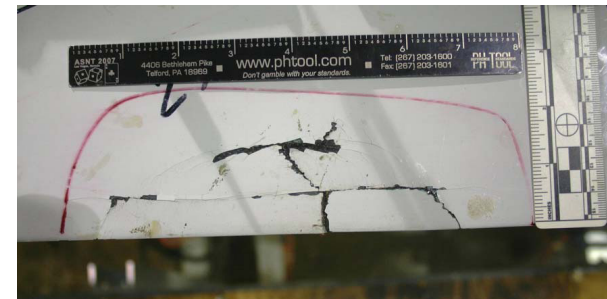
Damage on Aft Leading Edge

- Reference standards manufactured from LH wing pieces
- Inspection performed on all accessible surfaces of the aft wing
- Spars and ribs hard to access -> were not inspected
- Olympus BondMaster™ 1000+ (BM) used for inspection
- Tap testing used to supplement BM inspection
- BM utilizes a dual element, point contact, and dry coupled ultrasonic probe
