Inspection and Teardown of Aged In-Service Bonded Repairs

2016 Technical Review

Waruna Seneviratne, John Tomblin, and Brandon Saathoff

NATIONAL INSTITUTE
FOR AVIATION RESEARCH

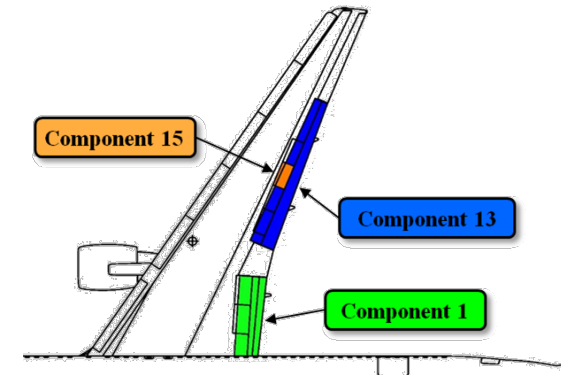
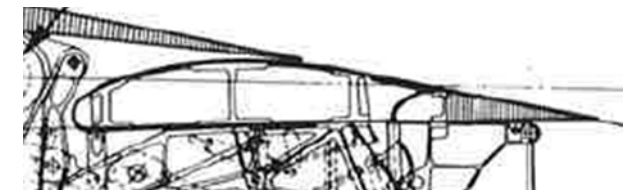
Component 1 – Subpanel Extraction (Metallic)

- *Need to verify if Aramid/Epoxy outer ply exists on lower skin.*
 - *If this is the case, repair 1g will not be considered.*
 - *These repairs have significant curvature near leading edge.*
