# Effects of Defects in Composite Materials at Elevated Strain Rates

NIAR-AVET

JAMS Technical Review

May 23<sup>rd</sup>, 2024

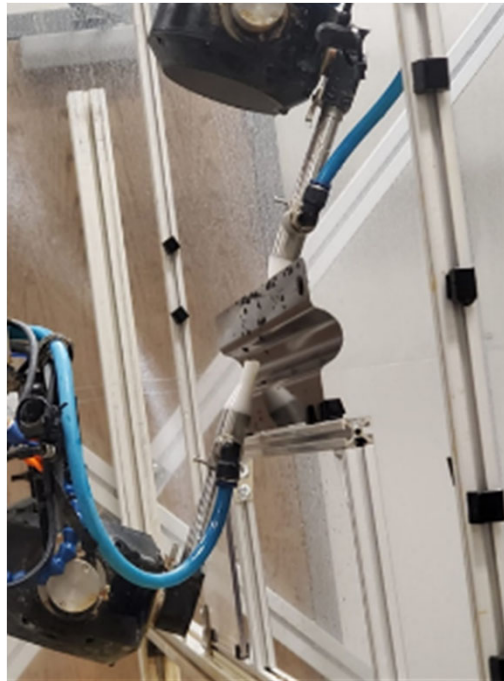
# Non-Destructive Inspection

- Equipment Details:
  - Manufacturer: TecScan
  - Nozzle diameter: 0.25"
  - Scan speed: 6 in/s
  - Transducer Type: Flat
- For each cure cycle, at least 2 laminates were inspected

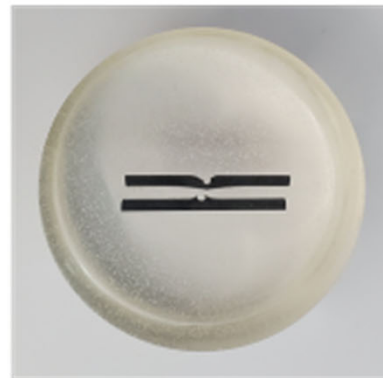
Potted specimen in clear epoxy

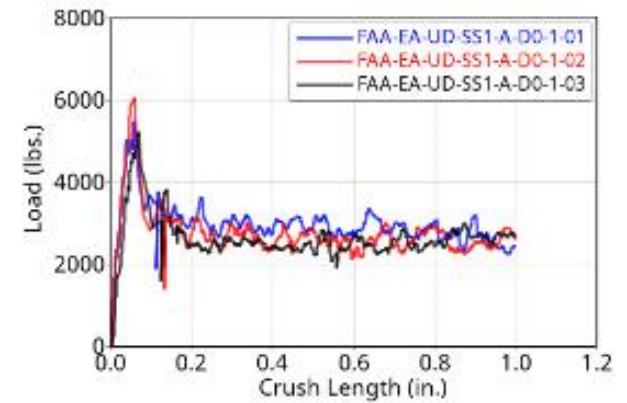
# Corrugated Beam (Pristine)

Defect Type: Pristine

Material System: IM7/8552; Stacking Sequence:  $[90^{\circ}/0^{\circ}]_{2s}$ ; Stroke Rate: 1 in/s

Specimen #	Peak Load [lbs.]	Sustained Load [lbs.]	Total SEA [in-lb/lb]	Total CFE
01	5,488.19	2,974.20	208,107.90	0.5419
02	6,070.71	2,749.10	192,357.44	0.4528
03	5,226.68	2,643.58	184,974.41	0.5058
COV	7.72%	6.06%	6.06%	8.96%

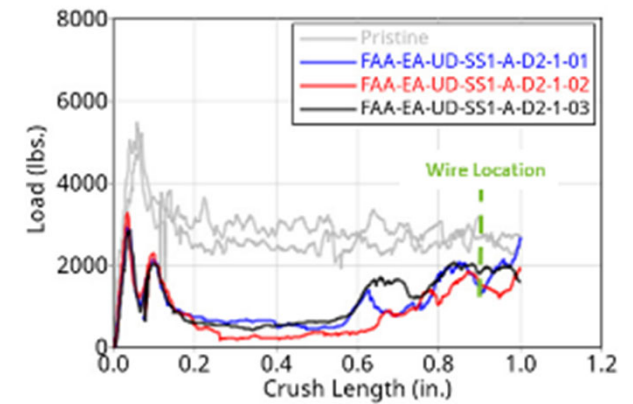
# Corrugated Beam (Waviness IML)

**Defect Type:** Waviness/Wrinkle (wire at IML)

**Material System:** IM7/8552; **Stacking Sequence:**  $[90^{\circ}/0^{\circ}]_{2s}$ ; **Stroke Rate:** 1 in/s

Specimen #	Peak Load [lbs.]	Sustained Load [lbs.]	Total SEA [in-lb/lb]	Total CFE
01	2,944.70	455.20	31,851.16	0.1546
02	3,284.10	377.49	26,413.45	0.1149
03	2,851.00	423.78	29,652.48	0.1486
COV	7.53%	9.33%	9.33%	15.34%

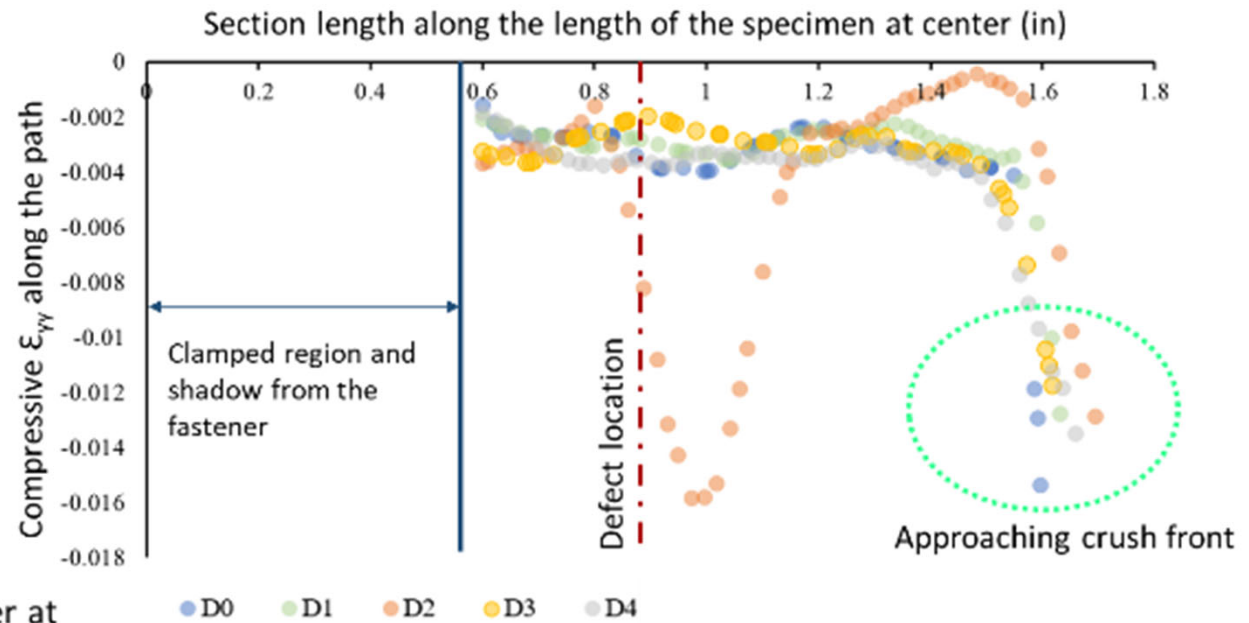
$\epsilon_{yy}$  from the center at peak load

D0 – Pristine; D1 – Waviness x OML; D2 – Waviness x IML; D3 – Delamination Flange; D4 – Delamination Web

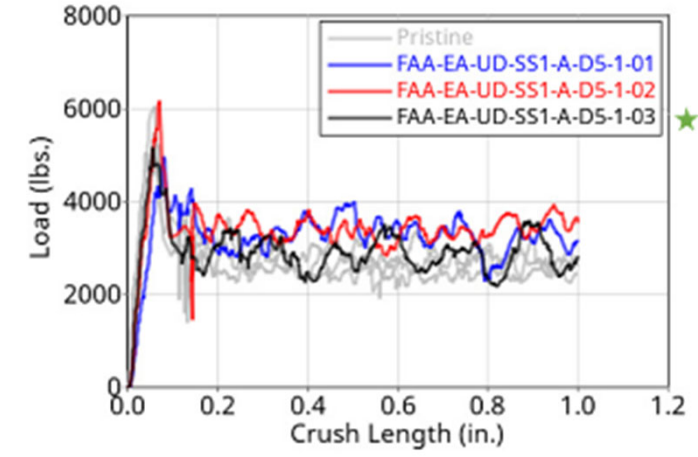
# Corrugated Beam (BVID)

**Defect Type:** Impact Energy 15 in-lb. (BVID)  
**Material System:** IM7/8552; **Stacking Sequence:**  $[90^{\circ}/0^{\circ}]_{2s}$ ; **Stroke Rate:** 1 in/s

Specimen #	Peak Load [lbs.]	Sustained Load [lbs.]	Total SEA [in-lb./lb.]	Total CFE
01	4,964.94	3,244.74	227,038.17	0.6535
02	6,184.21	3,408.42	238,490.60	0.5511
03	5,179.72	2,896.72	202,686.60	0.5592
COV	11.96%	8.21%	8.21%	9.68%

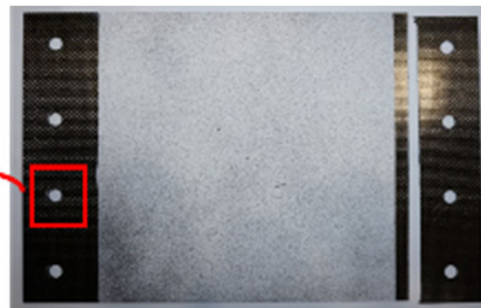
# Pristine Configuration

Defect Type: Pristine

Material System: AS4 PW/8552

Stacking Sequence:  $[0^\circ]_4$

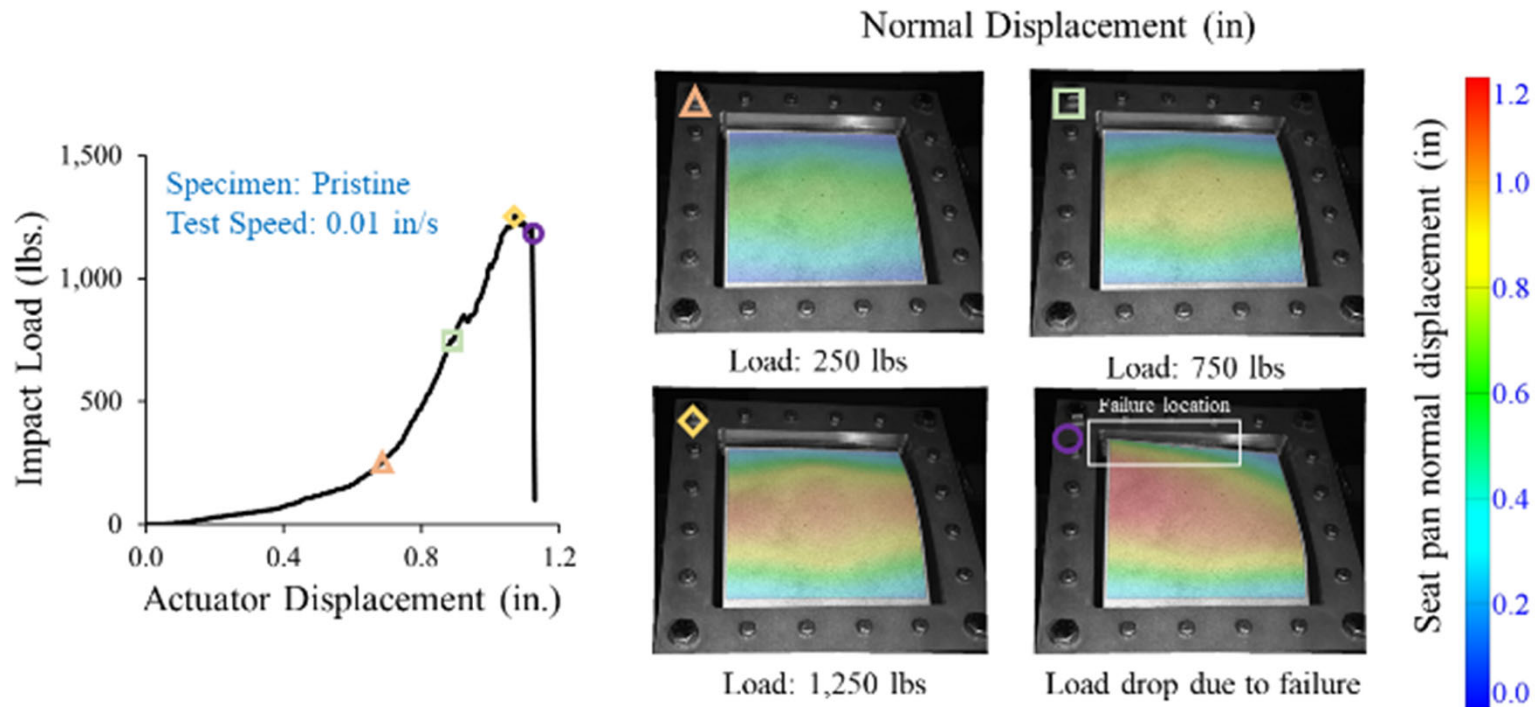
# Normal Displacements: Pristine

Configuration: Pristine; Test Speed: 0.01 in/s

- As the final failure occurs at the clamped edge, no significant difference was observed in failure load and normal displacement for both the configurations
- Due to the crack initiation at the vicinity of the wrinkle, the in-plane normal strains (and thus the strain rates) obtained at the center of the seatpan are higher in comparison to the pristine configuration

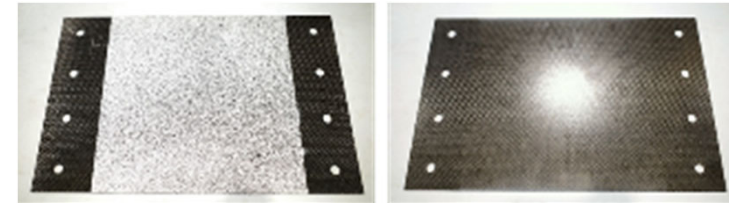
# Pristine Configuration

Front View

Back View

Defect Type: Pristine
