Effects of Defects in Composite Materials at Elevated Strain Rates

Joint Centers of Excellence for Advanced Materials

JAMS Technical Review

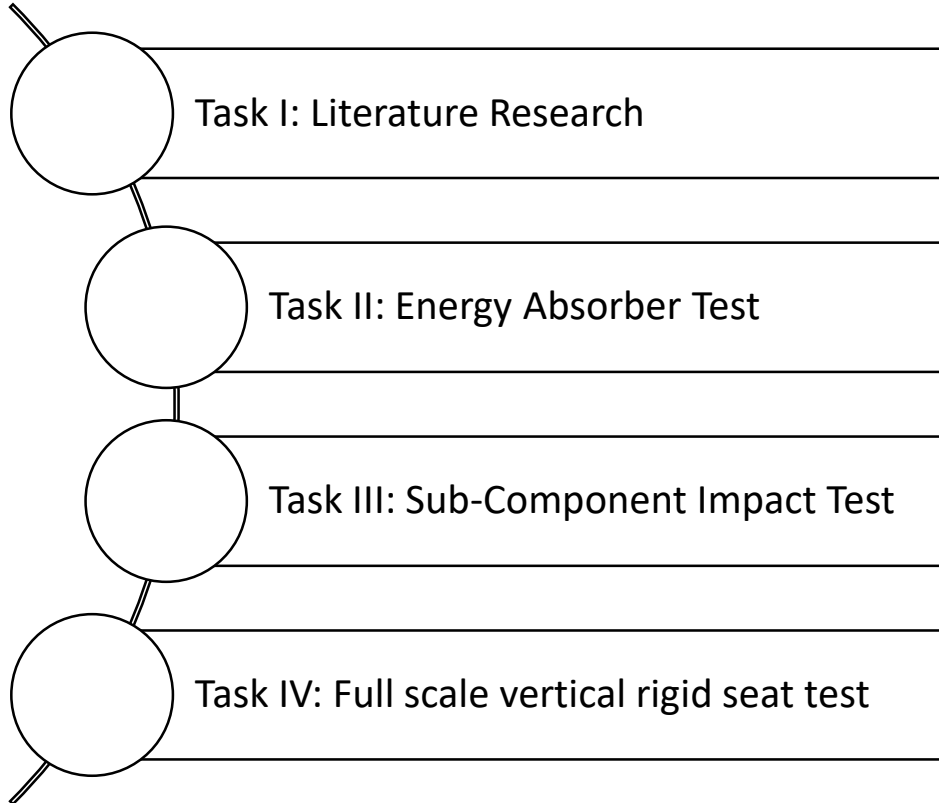
Project Task Breakdown & Approach

- **Task II:** Introduce prefabricated manufacturing defects and in-service damage on composite energy absorbers. Evaluate their crush performance and damage modes at multiple loading rates and compare them against their pristine counterparts.
- **Task III:** Introduce prefabricated manufacturing defect and in-service damage on representative flat composite seat pans. Conduct sub-component level impact tests at multiple loading rates and compare them against their pristine counterparts.
- **Task IV:** Introduce in-service damage on representative flat composite seat pans. Conduct full-scale vertical (rigid seat) tests to compare the performance of seat pans with damage against their pristine counterpart.

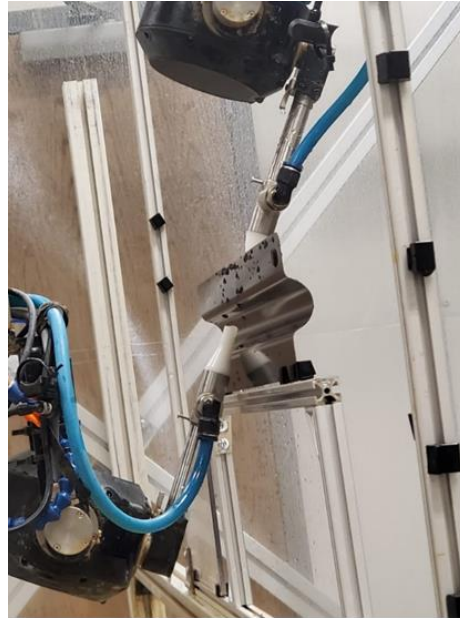
Non-Destructive Inspection

- Equipment Details:
 - Manufacturer: TecScan
 - Nozzle diameter: 0.25"
 - Scan speed: 6 in/s
 - Transducer Type: Flat
- For each cure cycle, atleast 2 laminates were inspected

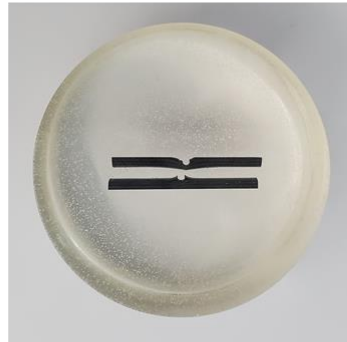
Potted specimen in clear epoxy

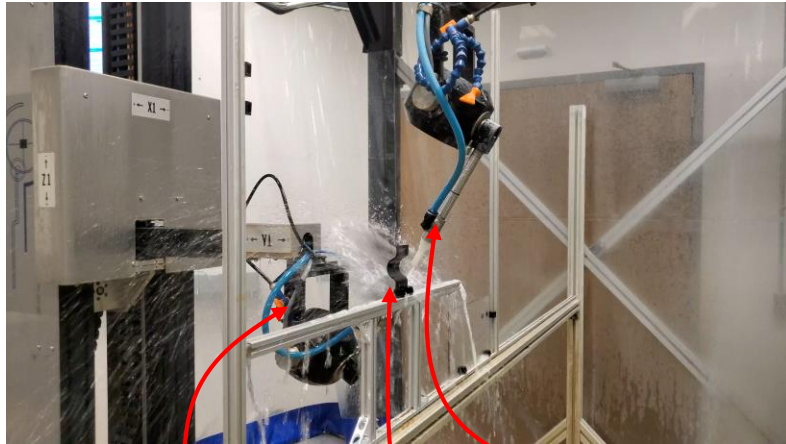
TTU C-Scan Setup for Corrugated Beam

X-axis tower, Y-axis
carriages and Z-Axis
Swivel assembly

Specimen

Equipment Information					
UT Instrument Manufacturer:	TecScan	Flaw Detector Manufacturer:	TecScan	Nozzle Size:	0.25 in Dia.
UT Instrument Model:	TecScan Side Arm Squirter System	Flaw Detector Model:	UTPR-50	Couplant:	Clean Water
Scan Parameters					
Scan Speed:	4 in/s	Scan Index:	0.02 in	Scan Mode:	TOF C-Scan
UT Parameters					
Gain:	7.0 dB	Sound Velocity:	0.102 in/us	Gate Type:	Backwall Interface
Frequency:	5 MHz	Damping Low Pass: High Pass:	33 Ohm Broadband 300 KHz	Gate Width: Gate Mode:	2.571 us Highest Peak
Transducer:	Flat	Voltage:	50 V	Gate Level:	5%
Range:	20 us	Delay:	90 us	Gate Position:	0.415 us

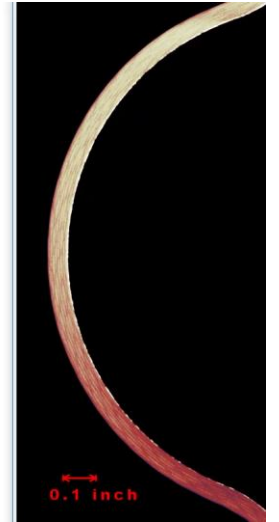
AS4 PW/8552; $[90^{\circ}/0^{\circ}]_{2S}$

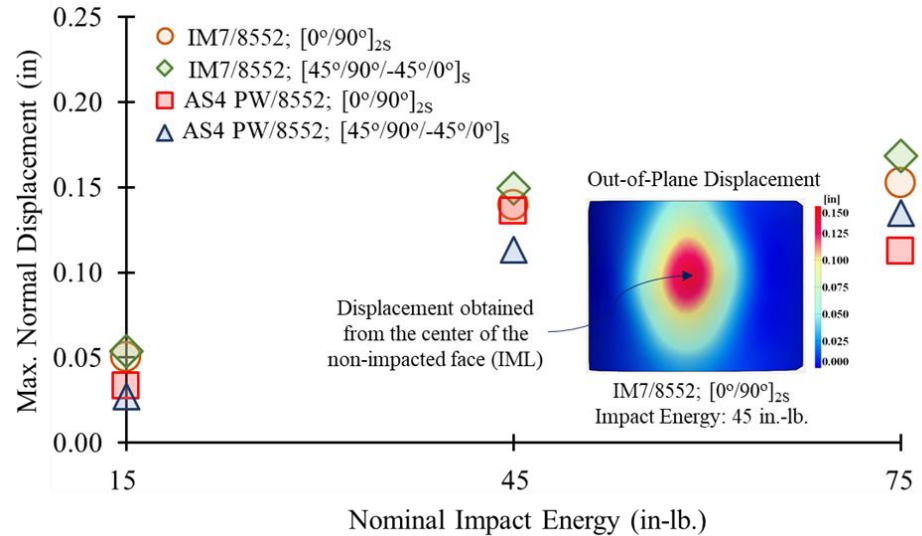
High Speed DIC: Corrugated Beam

IM7/8552; $[90^\circ/0^\circ]_{2S}$

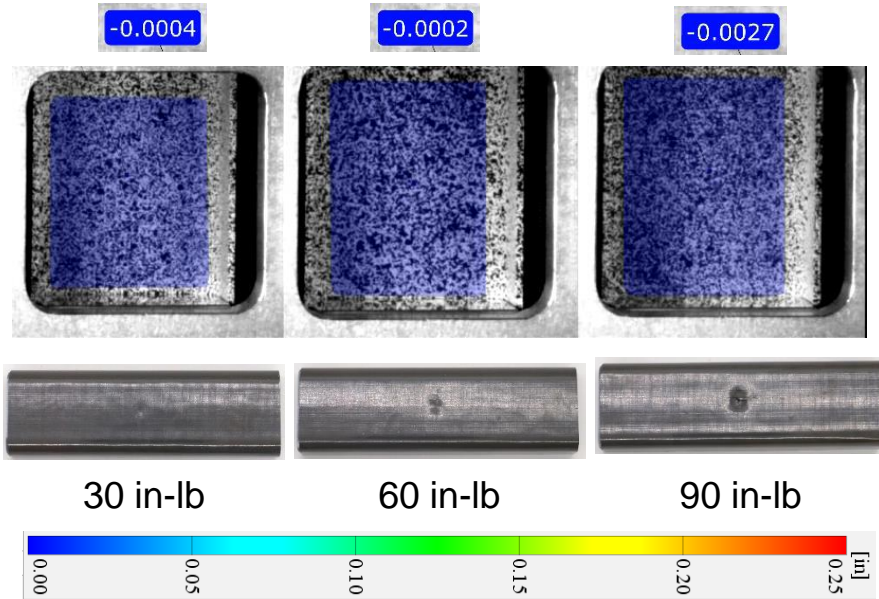
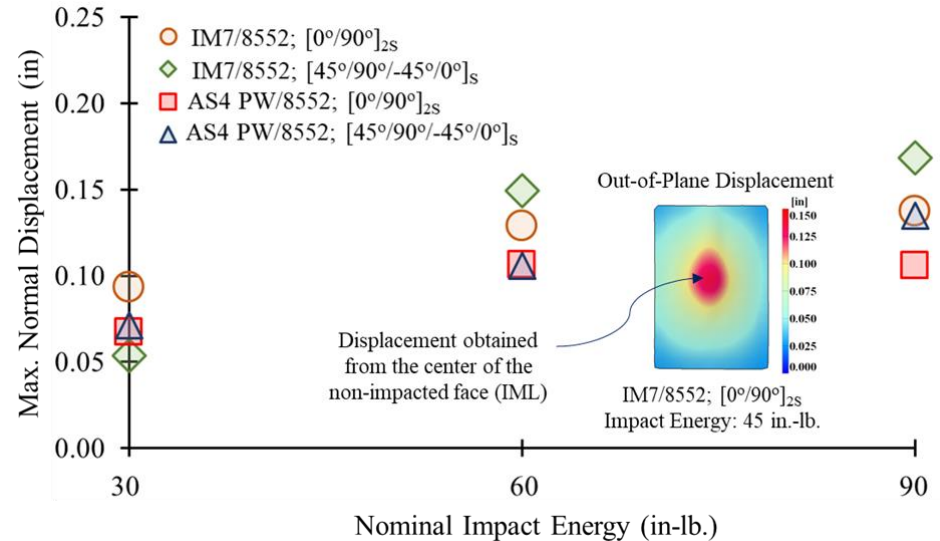
High Speed DIC: C-Channel

IM7/8552; $[90^{\circ}/0^{\circ}]_{2S}$

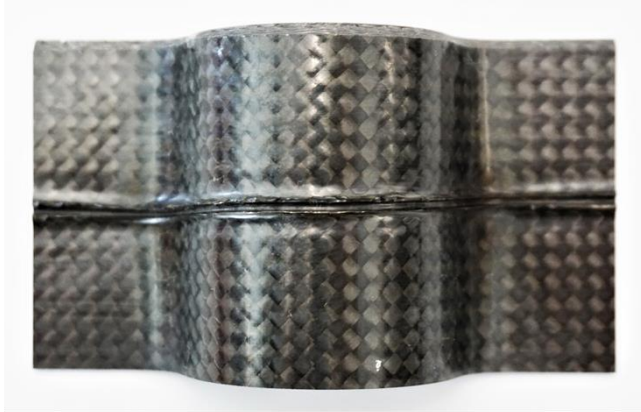
Client ID Test Method ID Material Type Stacking Sequence Energy Absorber Type Defect Type Stroke Rate Specimen ID

FAA-EA-PW-SS2-A-D1-1-02

Specimen Nomenclature		
Client ID	FAA	FAA
Test Method ID	Energy Absorber	EA
Material Type	Hexcel IM7/8552	UD
	Hexcel AS4 PW/8552	PW
Stacking Sequence	[90°/0°] _{2s}	SS1
	[45°/90°/-45°/0°] _s	SS2
Defect Type	Pristine	D0
	Fiber Waviness: OML	D1
	Fiber Waviness: IML	D2
	Delamination: Flange	D3
	Delamination: Web	D4
	Impact Energy Level I	D5
	Impact Energy Level II	D6
	Impact Energy Level III	D7
Energy Absorber Type	Corrugated Beam	A
	C-Channel Stanchion	B
Stroke Rate	0.01 in/s	0.01
	1 in/s	1
	100 in/s	100

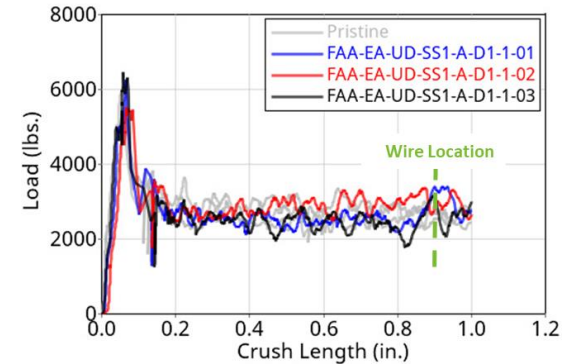
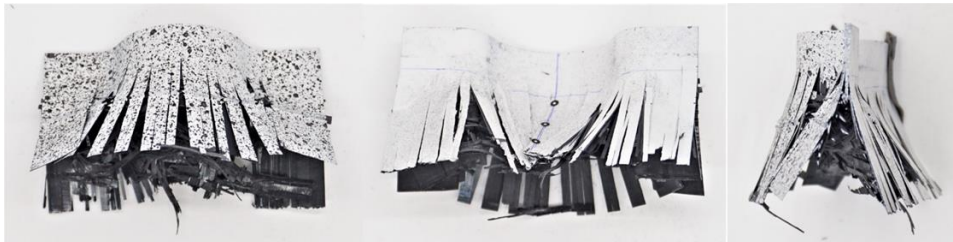
Corrugated Beam (Waviness OML)

Defect Type: Waviness/Wrinkle (wire at OML)

Material System: IM7/8552; **Stacking Sequence:** $[90^{\circ}/0^{\circ}]_{2s}$; **Stroke Rate:** 1 in/s

Specimen #	Peak Load [lbs.]	Sustained Load [lbs.]	Total SEA [in-lb/lb]	Total CFE
01	6,269.39	2,714.05	189,905.29	0.4329
02	5,523.62	2,918.13	204,184.98	0.5283
03	6,470.32	2,622.94	183,530.13	0.4054
COV	8.19%	5.49%	5.49%	14.16%

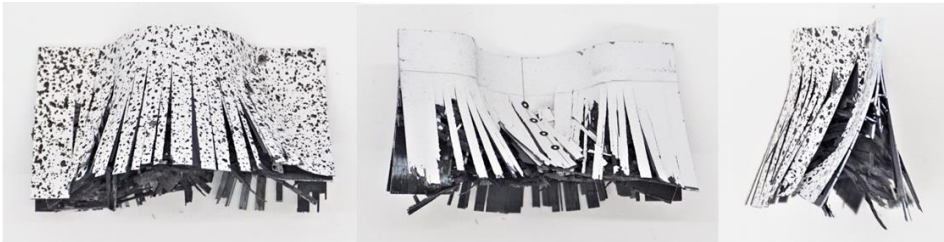
Corrugated Beam (Delam. Web)

Defect Type: Delamination (PTFE at Web)

Material System: IM7/8552; **Stroke Rate:** 1 in/s

Stacking Sequence: [90° /0°/Delamn/90°/0°/0°/90°/0°/90°]

Specimen #	Peak Load [lbs.]	Sustained Load [lbs.]	Total SEA [in-lb/lb]	Total CFE
01	5,874.24	2,907.16	203,416.85	0.4949
02	5,657.58	2,874.41	201,125.48	0.5081
03	5,347.13	3,004.81	210,249.50	0.5619
COV	4.71%	2.32%	2.32%	6.81%

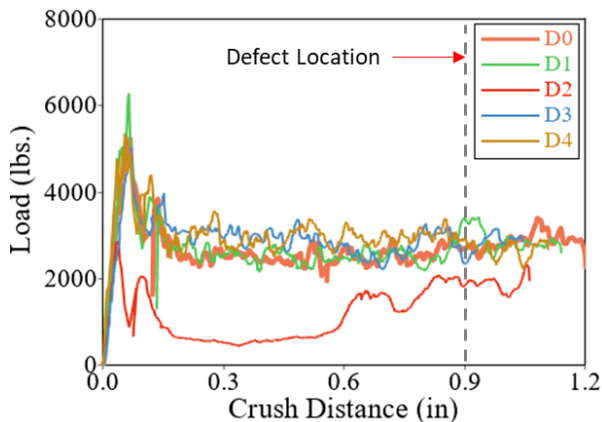
Comparison: Corrugated Beam IM7/8552; [90°/0°]_{2s}

% change in comparison to D0 (Pristine)		
Defect Type	Avg. Peak Load	Avg. Total SEA
D1	+8.80%	-1.34%
D2	-45.91%	-84.98%
D3	-2.07%	-1.48%
D4	+0.56%	+5.01%

D0 – Pristine; D1 – Waviness x OML; D2 – Waviness x IML; D3 – Delamination Flange; D4 – Delamination Web

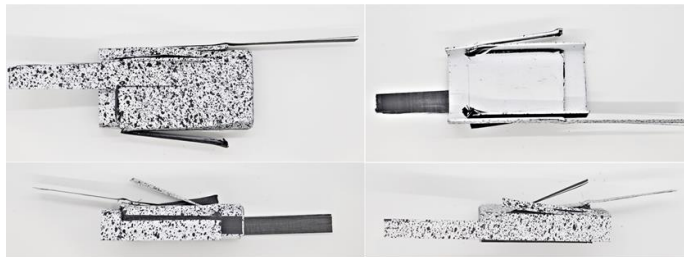
C-Channel (Waviness IML)

Defect Type: Waviness/Wrinkle (wire at IML)

Material System: IM7/8552;

Stacking Sequence: $[90^{\circ}/0^{\circ}]_{2s}$;

Stroke Rate: 1 in/s

Specimen #	Peak Load [lbs.]	Sustained Load [lbs.]	Total SEA [in-lb/lb]	Total CFE
01	2,735.72	380.49	34,575.94	0.1391
02	2,701.59	427.22	38,822.21	0.1581
03	2,527.71	350.07	31,811.21	0.1385
COV	4.20%	10.07%	10.07%	7.69%
