Post-Crash Fire Forensic Analysis on Aerospace Composites

JAMS Technical Review
September 23, 2021

Federal Aviation
Administration

Joint Centers of Excellence for Advanced Materials

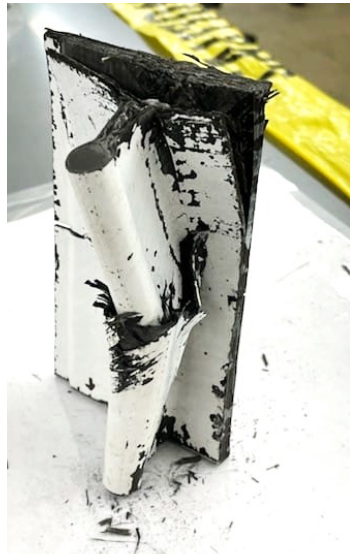
Stringer-1

- Mechanically failed stringer elements

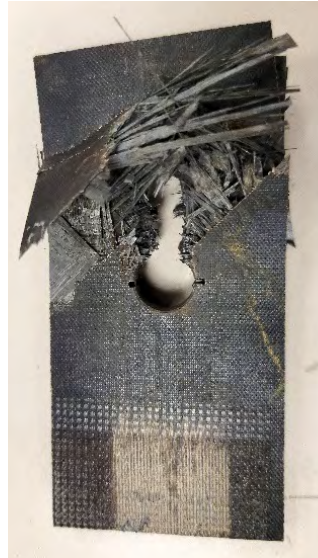
Open hole-1

- Mechanically failed open hole specimens

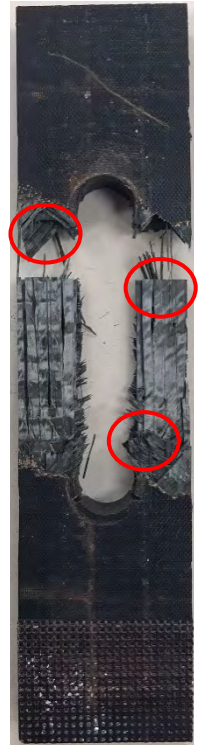
Pre-Fire Exposure Fractography of Mechanically Failed PRSEUS Carbon-Epoxy Open Hole Specimen

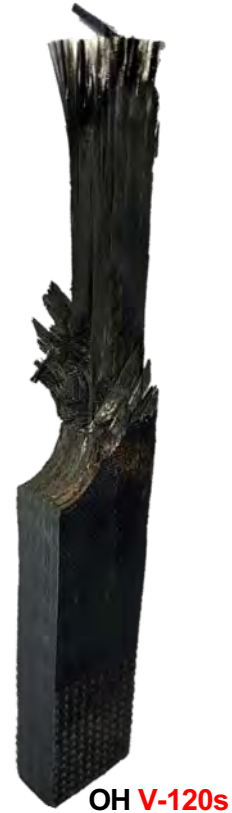
Post V-120s Fire Exposure Fractography of Mechanically Failed PRSEUS Carbon-Epoxy Open Hole specimen
